| Meeting: | BLUNTISHAM IDB | Subject: | CONSULTING ENGINEERS REPORT:<br>CHIEF ENGINEER'S SUMMARY &<br>CAPITAL PROGRAMME |
| Date: | Friday 16 January 2026 | Officer<br>Responsible: | Nicola Oldfield |

| Meeting: | BLUNTISHAM IDB | Subject: | CONSULTING ENGINEERS REPORT:<br>MECHANICAL & ELECTRICAL |

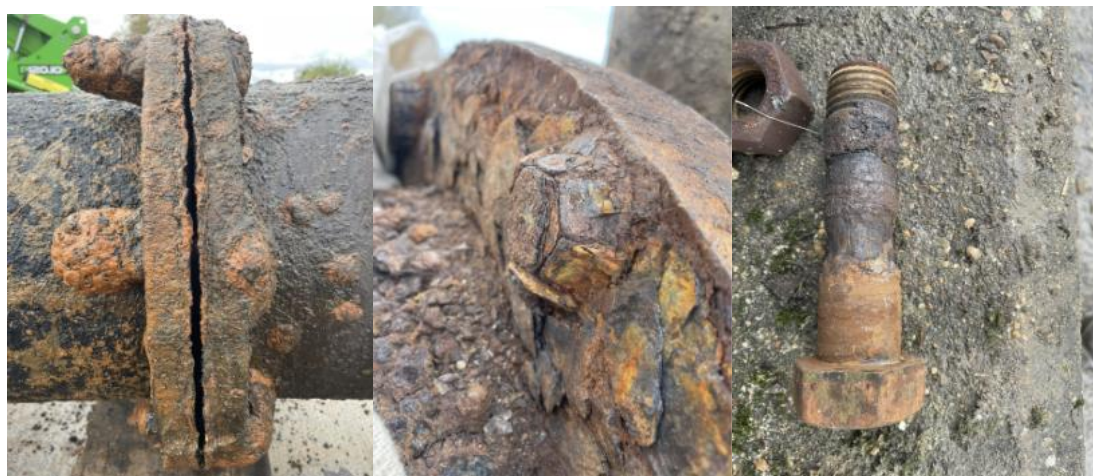
The pictures below are of pump bolts that have been in situ for 20 years and have corroded to the point of failure as shown by the gap between the flanges. Although now rebuilt with stainless steel bolts they were not in the past. The pump tubes are also heavily corroded which reduces pump life considerably. Ideally pumps should be refurbished every 10 years because by the time they reach 15 to 20 years it is likely the corrosion will heavily impact their overall residual life.

**The Board is strongly advised to consider the development of an investment plan for asset refurbishment/replacement. The Board is asked to instruct the Consulting Engineer accordingly.**
