| Meeting: | SUTTON & MEPAL IDB<br>(Hereafter referred to as the Board) | Subject: | CONSULTING ENGINEERS REPORT:<br>CHIEF ENGINEER'S SUMMARY AND<br>CAPITAL PROGRAMME |
| Date: | Thursday 15 January 2026 | Officer<br>Responsible: | Nicola Oldfield |

| Meeting: | <b>SUTTON &amp; MEPAL IDB<br/>(Hereafter referred to as the Board)</b> | Subject: | <b>CONSULTING ENGINEERS REPORT:<br/>MECHANICAL &amp; ELECTRICAL</b> |

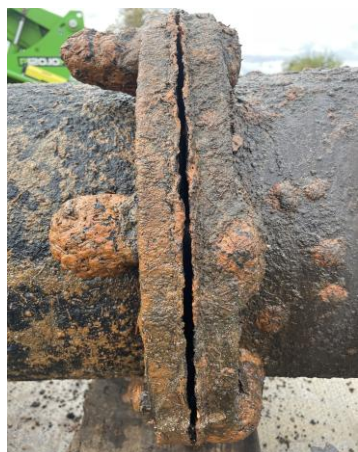
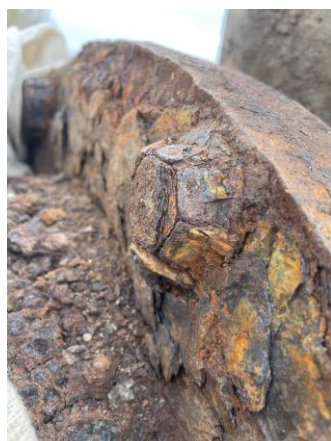
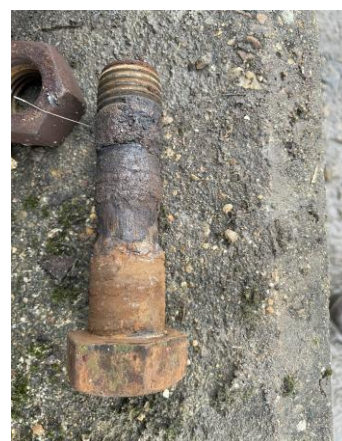
The pictures below are of pump bolts that have been in situ for 20 years and have corroded to the point of failure as shown by the gap between the flanges. Although now rebuilt with stainless steel bolts they were not in the past. The pump tubes are also heavily corroded which reduces pump life considerably. Ideally pumps should be refurbished every 10 years because by the time they reach 15 to 20 years it is likely the corrosion will heavily impact their overall residual life.
