| Meeting: | <b>MANEA &amp; WELNEY DDC</b><br>(Hereafter referred to as the Board) | Subject: | <b>CONSULTING ENGINEERS REPORT: CHIEF ENGINEER'S SUMMARY &amp; CAPITAL PROGRAMME</b> |
| Date: | <b>Wednesday 28<sup>th</sup> January 2026</b> | Officer Responsible: | <b>Nicola Oldfield</b> |

| Meeting: | MANEA & WELNEY DDC (Hereafter referred to as the Board) | Subject: | CONSULTING ENGINEERS REPORT: MECHANICAL & ELECTRICAL |

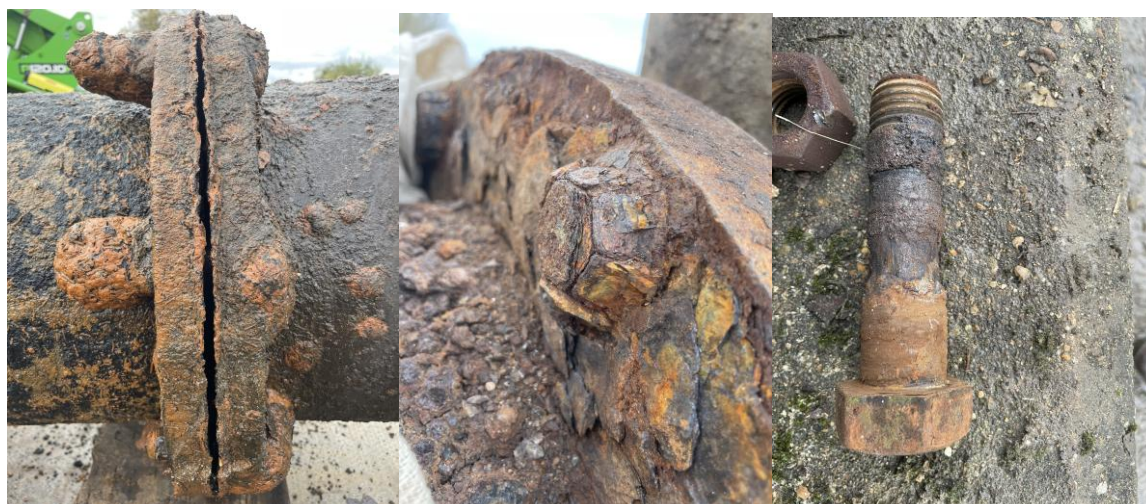
The pictures below are of pump bolts that have been in situ for 20 years and have corroded to the point of failure as shown by the gap between the flanges. Although now rebuilt with stainless steel bolts they were not in the past. The pump tubes are also heavily corroded which reduces pump life considerably. Ideally pumps should be refurbished every 10 years because by the time they reach 15 to 20 years it is likely the corrosion will heavily impact their overall residual life.
