| Meeting: | EUXIMOOR IDB (Hereafter referred to as the Board) | Subject: | CONSULTING ENGINEERS REPORT: CHIEF ENGINEER'S SUMMARY & CAPITAL PROGRAMME |
| Date: | Thursday 4 <sup>th</sup> June 2026 | Officer Responsible: | Nicola Oldfield |

| Meeting: | EUXIMOOR IDB<br>(Hereafter referred to as the Board) | Subject: | CONSULTING ENGINEERS REPORT:<br>MECHANICAL & ELECTRICAL |

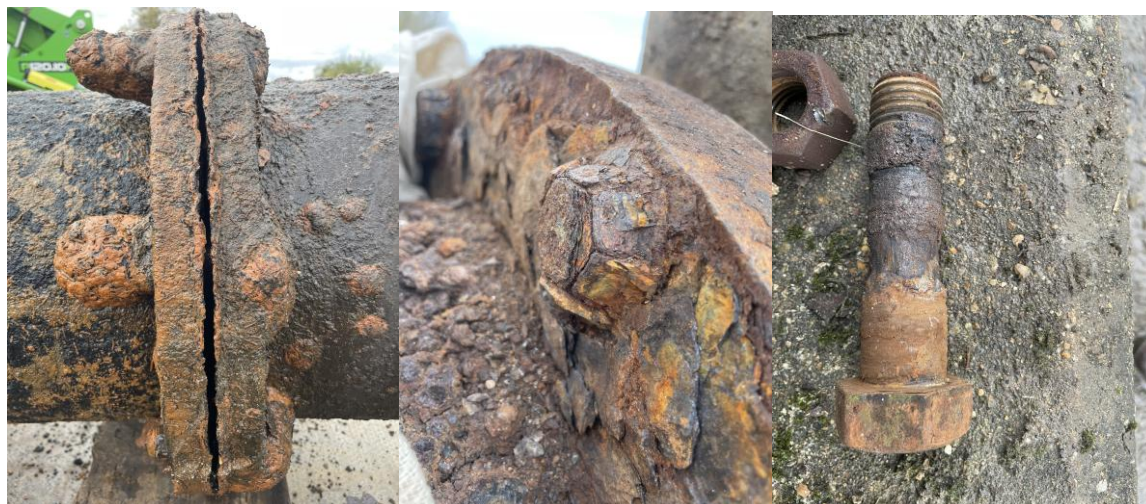
The pictures below are of pump bolts that have been in situ for 20 years and have corroded to the point of failure as shown by the gap between the flanges. Although now rebuilt with stainless steel bolts they were not in the past. The pump tubes are also heavily corroded which reduces pump life considerably. Ideally pumps should be refurbished every 10 years because by the time they reach 15 to 20 years it is likely the corrosion will heavily impact their overall residual life.
