| Meeting: | <b>BENWICK IDB (Hereafter referred to as the Board)</b> | Subject: | <b>CONSULTING ENGINEERS REPORT: CHIEF ENGINEER'S SUMMARY &amp; CAPITAL PROGRAMME</b> |
| Date: | <b>Wednesday 17<sup>th</sup> June 2026</b> | Officer Responsible: | <b>Nicola Oldfield</b> |

| Meeting: | <b>BENWICK IDB<br/>(Hereafter referred to as the Board)</b> | Subject: | <b>CONSULTING ENGINEERS REPORT:<br/>OPERATIONAL SERVICES</b> |

| Meeting: | BENWICK IDB (Hereafter referred to as the Board) | Subject: | CONSULTING ENGINEERS REPORT: MECHANICAL & ELECTRICAL |

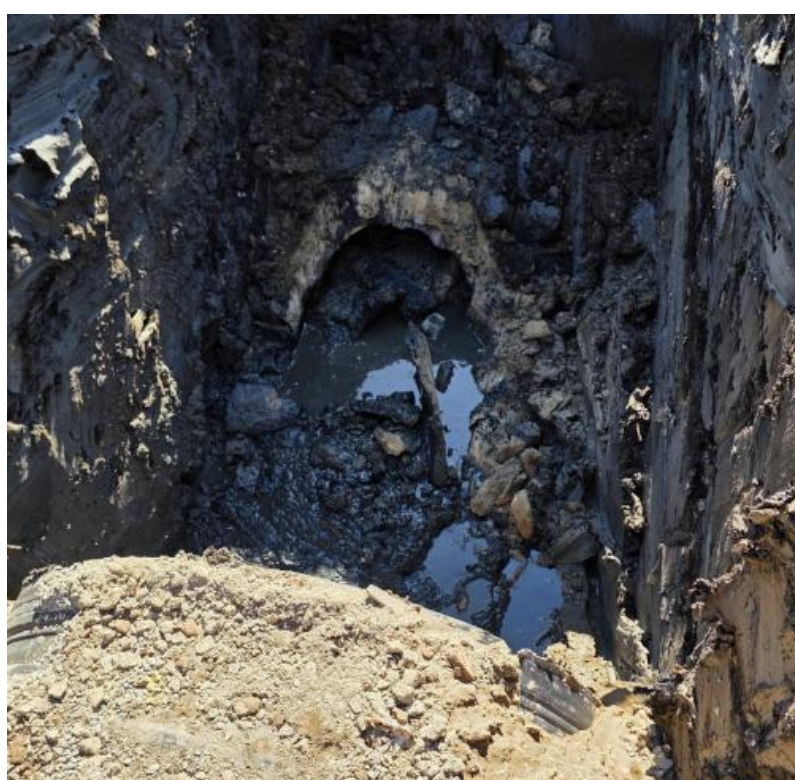
Point 52, Culvert Replacement. New 1800mm pipe in the bottom of picture & old silted up 900mm pipe in the top.

The Board was successful in securing funding for improvement works from the DEFRA IDB assets resilience grant and the mobile pumps package. This allowed for fully funded culvert replacement at point 52 on the Ramsey Road to the West of Benwick village. Historically Bettys Nose pumping station has struggled to evacuate the water from the village of Benwick, with long delays at the pumping station, before the water levels equalled the same as the ones in the village. Once the works commenced, it was evident the 900mm culvert was not only too small, but it was almost full with silt as water depths at the culvert would have required the drain to be dammed off and de-watered, to allow the old culvert to be cleaned out. The replacement 1800mm twin-wall plastic pipe, will provide a much greater water conveyance and suffer less from silting up in the future due to the greater diameter and part of the pipe being above water level.

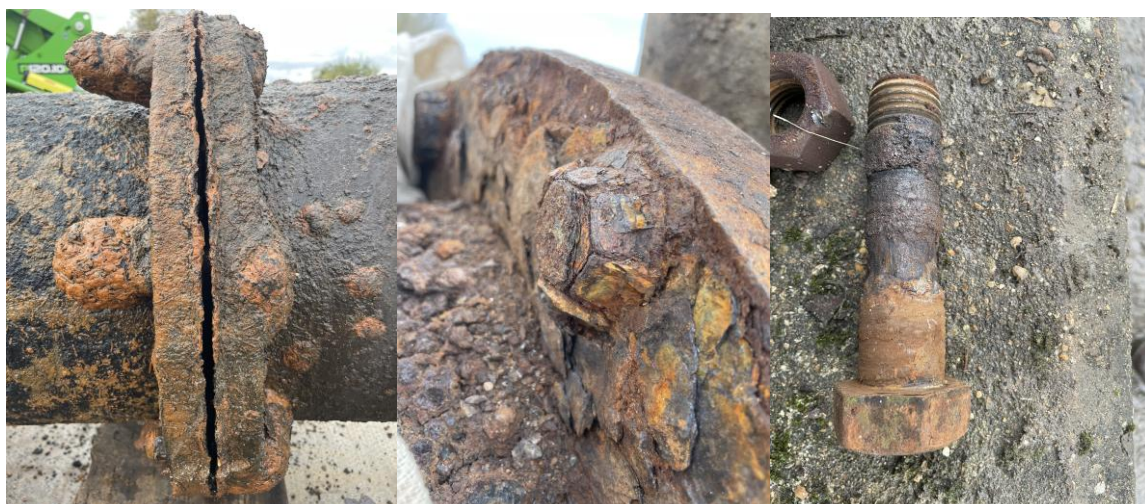
The pictures below are of pump bolts at Ramsey Mere that have been in situ for 20 years and have corroded to the point of failure as shown by the gap between the flanges. Although now rebuilt with stainless steel bolts they were not in the past. The pump tubes are also heavily corroded which reduces pump life considerably. Ideally pumps should be refurbished every 10 years because by the time they reach 15 to 20 years it is likely the corrosion will heavily impact their overall residual life.

The pump and motor have been overhauled. The pump casing and bolts were heavily corroded and close to failing. The weedscreen cleaner has had a full overhaul complete with new control panel.
