| Meeting: | UPWELL IDB (Hereafter referred to as the Board) | Subject: | CONSULTING ENGINEERS REPORT:<br>CHIEF ENGINEER'S SUMMARY & CAPITAL PROGRAMME |
| Date: | Wednesday 21 <sup>st</sup> January 2026 | Officer Responsible: | Nicola Oldfield |

| Meeting: | UPWELL IDB | Subject: | CONSULTING ENGINEERS REPORT:<br>MECHANICAL & ELECTRICAL |

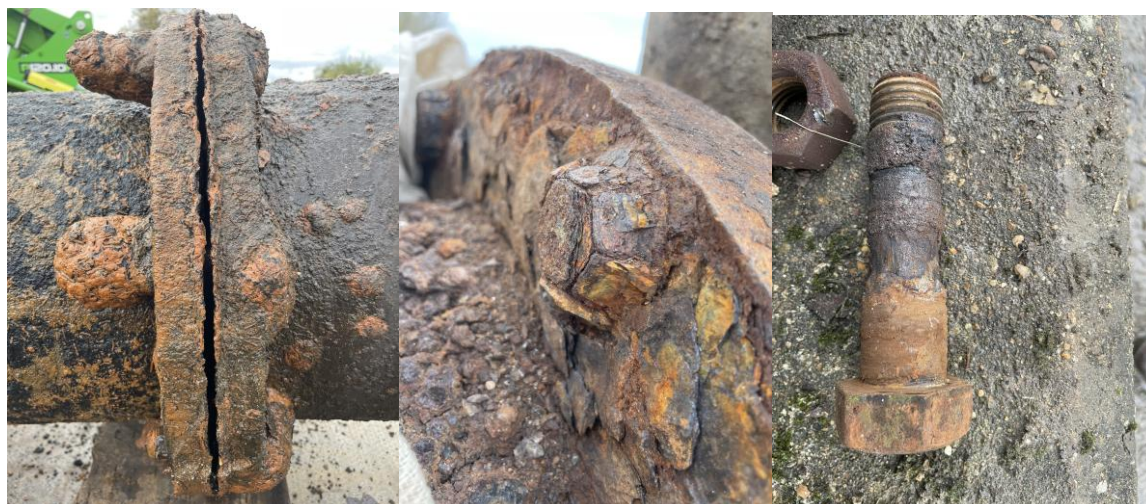
The pictures below are of pump bolts that have been in situ for 20 years and have corroded to the point of failure as shown by the gap between the flanges. Although now rebuilt with stainless steel bolts they were not in the past. The pump tubes are also heavily corroded which reduces pump life considerably. Ideally pumps should be refurbished every 10 years because by the time they reach 15 to 20 years it is likely the corrosion will heavily impact their overall residual life.
