| Meeting: | UPWELL IDB (Hereafter referred to as the Board) | Subject: | CONSULTING ENGINEERS REPORT:<br>CHIEF ENGINEER'S SUMMARY & CAPITAL PROGRAMME |
| Date: | Wednesday 10 <sup>th</sup> June 2026 | Officer Responsible: | Nicola Oldfield |

| Meeting: | UPWELL IDB | Subject: | CONSULTING ENGINEERS REPORT:<br>MECHANICAL & ELECTRICAL |

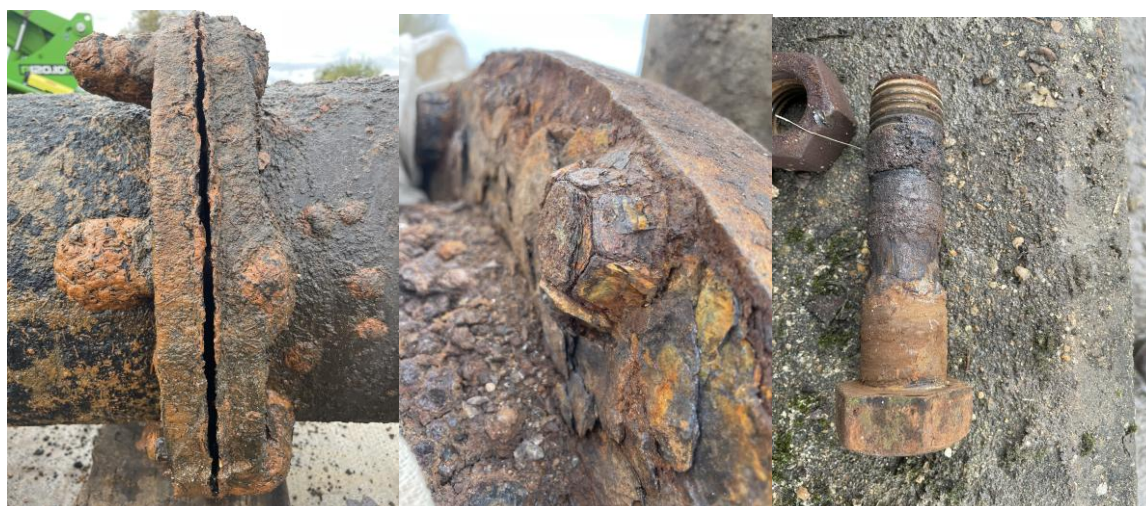
The pictures below are of pump bolts that have been in situ for 20 years (not an Upwell IDB site) and have corroded to the point of failure as shown by the gap between the flanges. Although now rebuilt with stainless steel bolts they were not in the past. The pump tubes are also heavily corroded which reduces pump life considerably. Ideally pumps should be refurbished every 10 years because by the time they reach 15 to 20 years it is likely the corrosion will heavily impact their overall residual life.
