**middle level  
commissioners**

**The effectiveness of installing coir roll revetments  
to improve riparian habitats for water voles (*Arvicola amphibius*)  
along Fenland drains.**

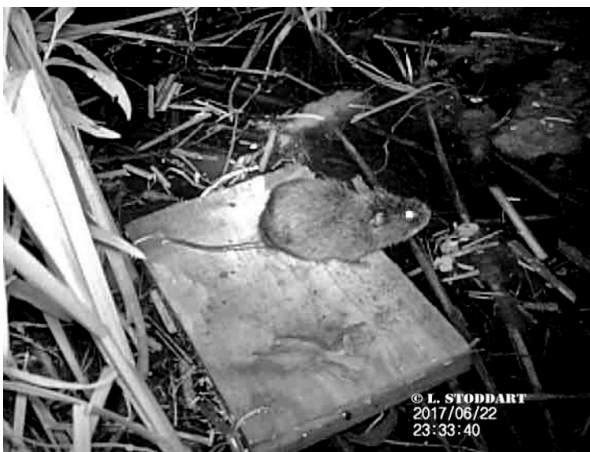
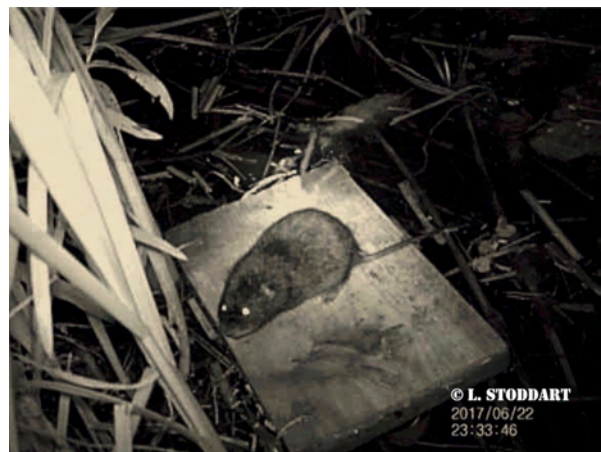
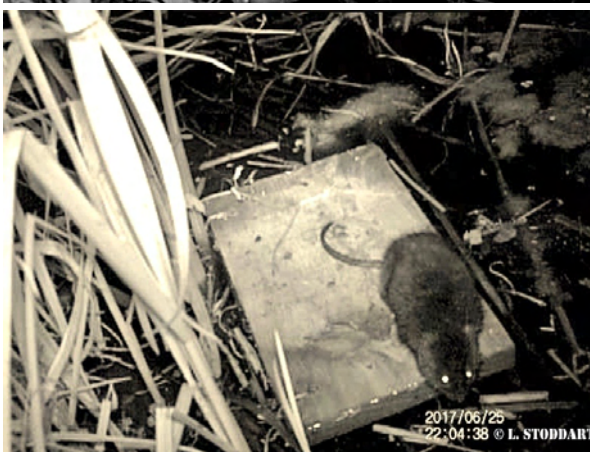
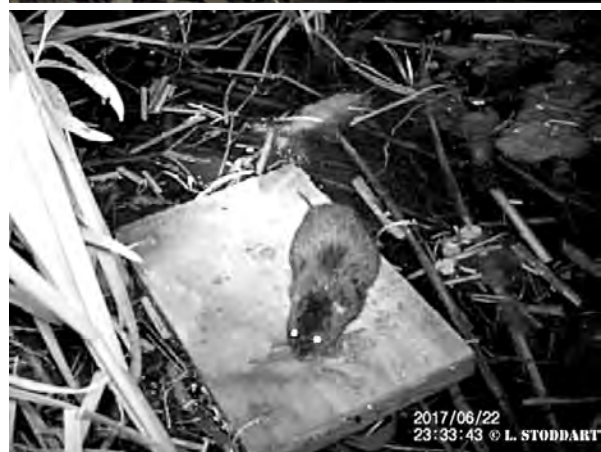
Photos: One of the 110 survey rafts (acting as an artificial latrine and feeding platform) being used by a water vole at the edge of a Fenland drain (L. Stoddart, 2017).

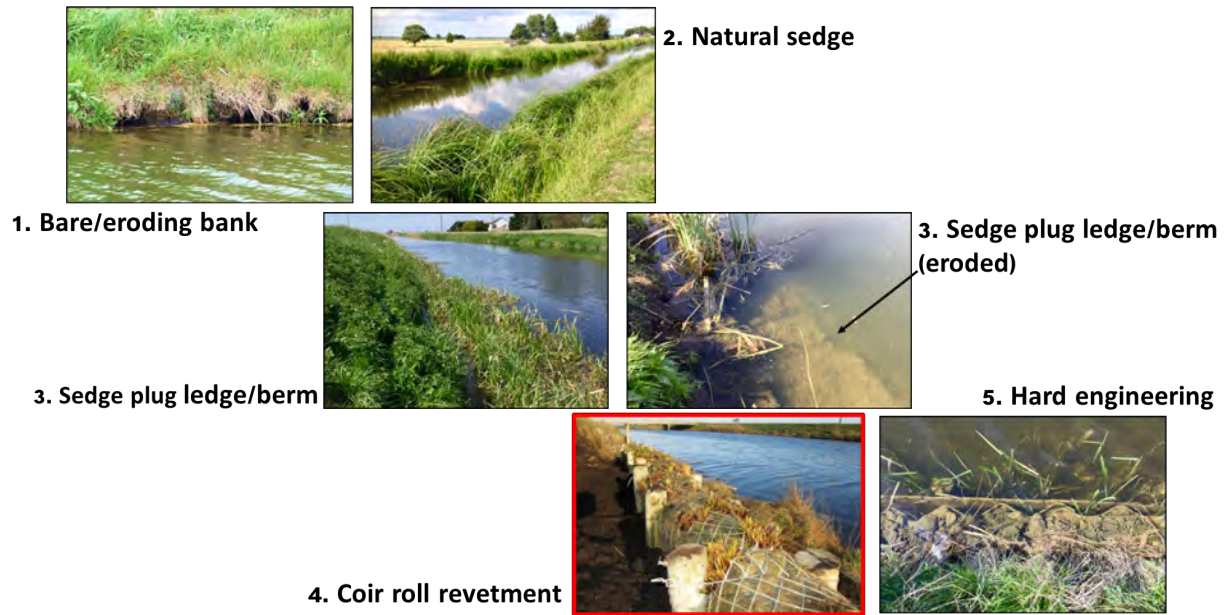
**Figure 1.** The five management types surveyed for water voles during the study, with coir roll revetment outlined in red (C. Carson, 2009; L. Stoddart, 2017).

- 1) *Bare bank*: Devoid of any management (hard engineering or bioengineering) and partially eroded (<50% of the bank toe's length was vegetated).
- 2) *Natural sedge bank*: >50% of the water's edge vegetation was comprised of sedge species (Cyperaceae). Devoid of bank management, other than annual or biannual mowing.

- 3) *Sedge plug ledge*: A circa 30 cm wide soil shelf (also known as a berm) installed just above the summer water level and planted with pre-established lesser pond sedge plugs (*Carex acutiformis*).

- 4) *Coir roll revetment*: A type of organic living revetment consisting of a series of 3 m long by 30 cm diameter cylindrical meshed nets containing coir (coconut husk material) and five pre-established riparian plant species (lesser pond sedge (*Carex acutiformis*); purple loosestrife (*Lythrum salicaria*); yellow flag iris (*Iris pseudacorus*); reed canary grass (*Phalaris arundinacea*); soft rush (*Juncus effusus*)). Coir rolls are secured against the bank at the water's edge using wooden posts. Section lengths needed to measure >21 m for statistical purposes.

- 5) *Hard engineering*: Corrugated metal sheets and wooden boards enclosing flint stones at the water's edge.

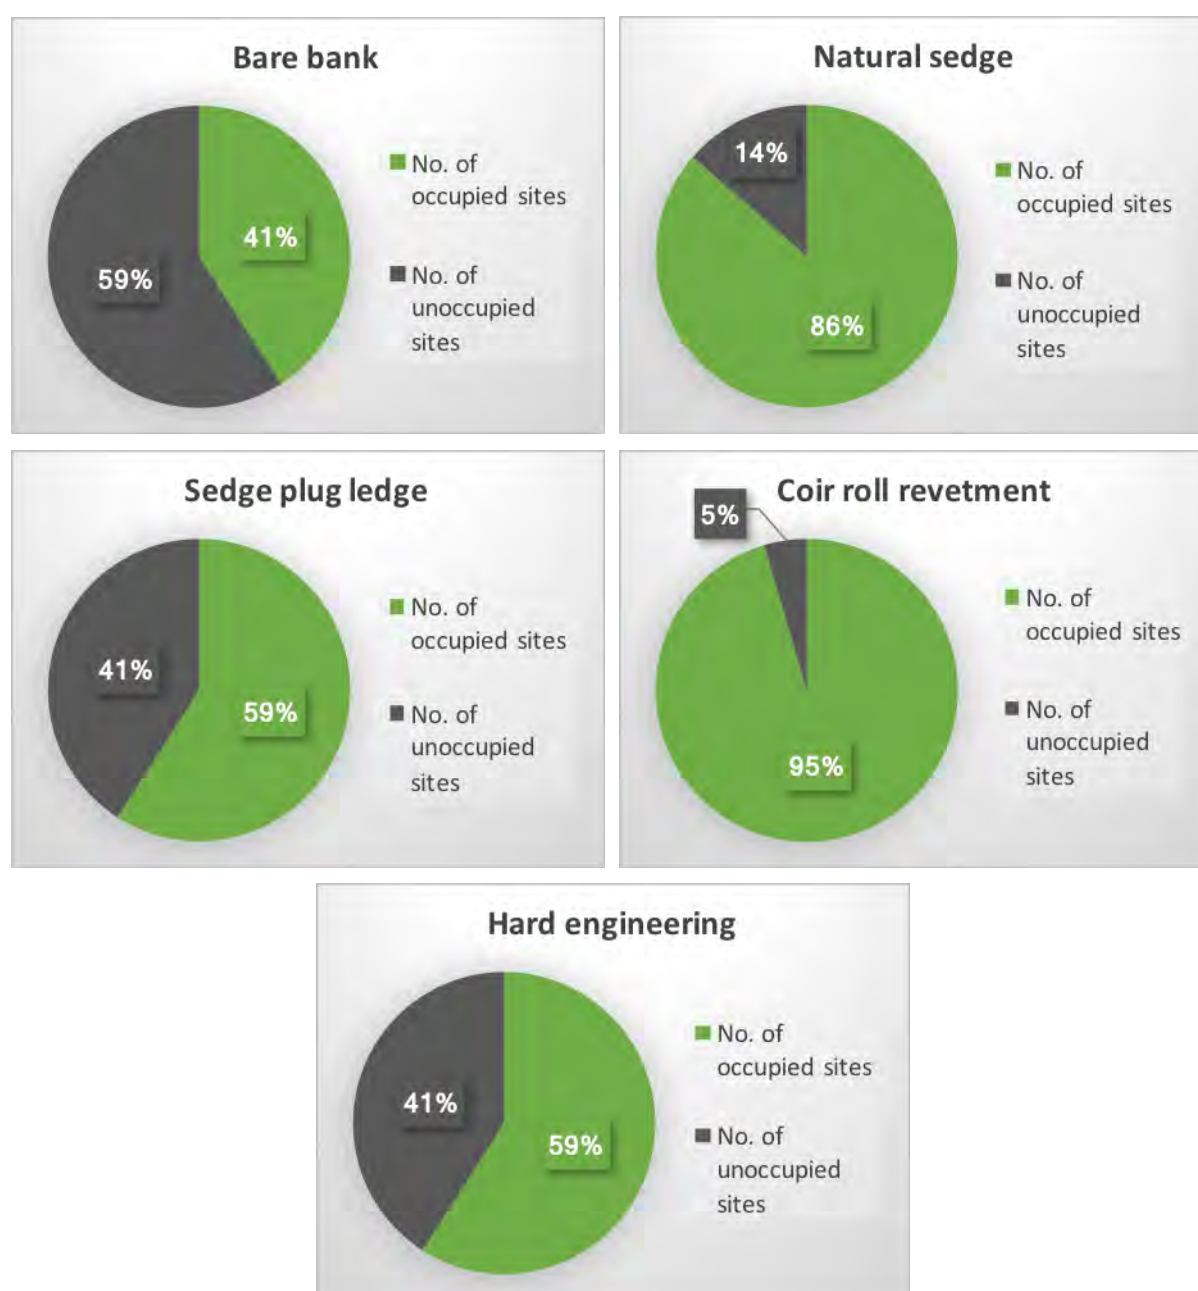
**Figure 3.** Percentage of the 22 survey sites occupied by water voles for each management type.

The latrine presence/absence data revealed that 21/22 (95.45%) of the coir roll revetment survey sites were occupied by breeding water voles (latrines recorded during at least one of the four survey visits) (Table 1, Figure 3). More coir roll revetment sites were occupied than sites of any other management type, with their occupancy being even higher than natural sedge, which had 19/22 (86.36%) of occupied sites. Bare bank was the least occupied management type, with only 9/22 (40.91%) of sites being occupied (less than half the number of occupied sites than that of coir roll revetments).

Hard engineering and sedge plug ledge management types both yielded a moderate site occupancy (13/22 or 59.09%) (Table 1, Figure 3). Occupancy of hard engineering sites was perhaps higher than expected considering the impenetrable materials from which the management type is formed, and the comparatively low plant diversity. On the other hand, occupancy of sedge plug ledge sites (a much softer management approach) was perhaps lower than expected. This could partly be attributed to the fact that the ledges offered limited protection for the young sedge plugs, which were therefore eroded and failed to become established. Consequently, the vegetation cover in this management type was generally relatively low. There is an indication that erosion protection is an important and pivotal factor in determining vegetation cover of banks, and therefore suitability for water voles. It is possible that a trade-off between the effective erosion protection offered by harder engineering options, and preferential bank/vegetation characteristics offered by softer approaches must be met in order to achieve the highest occupancy. Coir roll revetments possibly meet this compromise effectively, as the dense, protective coconut husk material and meshed netting, supported by wooden posts may absorb the hydraulic power of the river. These features have likely allowed the plants within the coir rolls, and the surrounding bank vegetation to avoid erosion damage and become established, whilst simultaneously still offering a bank which is penetrable to burrowing water voles. Another explanation for the success of coir roll revetments (and indeed natural sedge banks), is that they both have a high abundance of sedge (Figure 6), a key provider of food and shelter for water voles (Bonesi et al., 2002; Strachan et al., 2011). Bare bank and hard engineering sites were distinctly lacking in sedge, whilst the sedge which had been planted at sedge plug ledge sites had largely been eroded away or replaced by common reed (*Phragmites australis*). The lack of sedge (and the reduced vegetation diversity in general) at bare bank sites is likely due to the lack of protection from erosion.

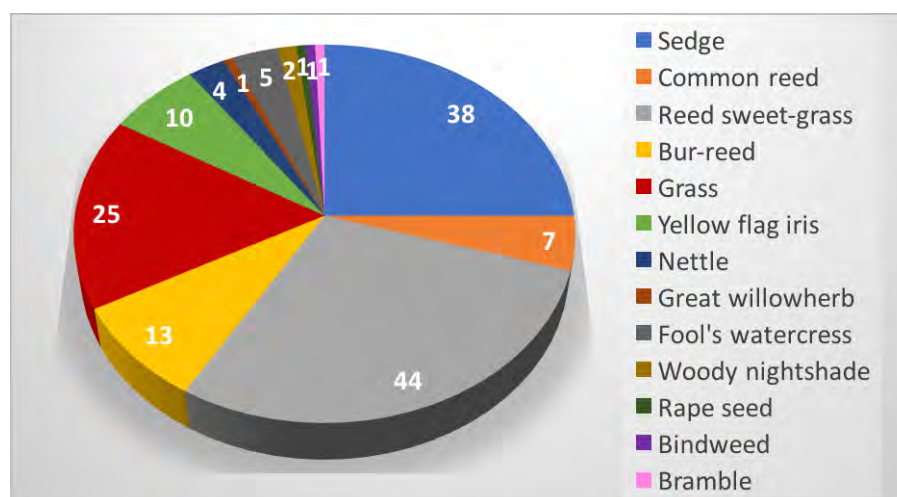
**Figure 4.** The number of all 440 site survey visits during which plant groups were identified from feeding remains across all management type survey sites.

Across all 440 survey site visits, 13 plant groups were identified from feeding remains (Figure 4). Of these plant groups, reed sweet-grass was recorded 44 times (10% of all visits), making it the most commonly recorded food plant. The second most frequently recorded food plant was sedge (during 38/440 or 8.64% of survey visits) and the third was grass (during 25/440 or 5.68% of survey visits). The feeding remains data suggest that sedge was the preferred food source, however when sedge was not readily available, reed sweet-grass was the main substitute (compare Figure 5 with Figure 6). For example, at bare bank sites (which incidentally, had the lowest water vole occupancy), reed sweet-grass was recorded on 20/33 occasions (over half of all feeding remains recordings) (Figure 5). Conversely, coir roll revetment sites (which had the highest occupancy) were dominated by sedge and subsequently had the most sedge feeding remains.

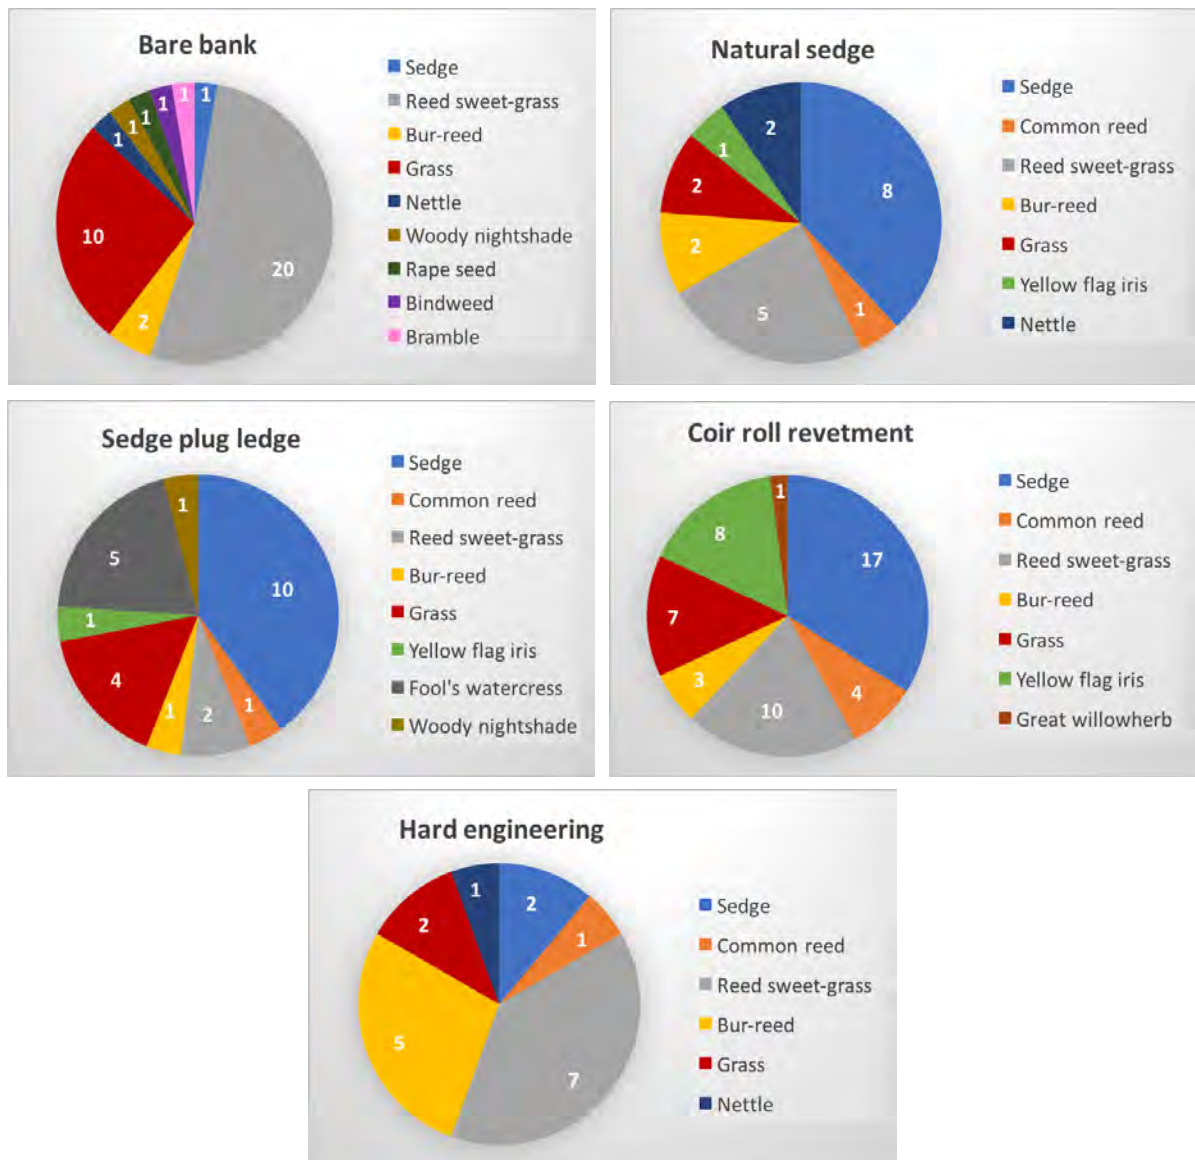
**Figure 5.** The number of survey visits during which plant groups were identified from feeding remains at each management type (four visits at each management type's 22 sites).

Generally, water vole occupancy appears to be positively correlated with the number of survey visits during which sedge feeding remains were found (compare Figure 5 with Figure 6). This is especially true for coir roll revetment ( $n = 17$ ) and natural sedge sites ( $n = 8$ ), which had the most occupied sites. However, sedge feeding remains were also found during a relatively high number of sedge plug ledge survey visits ( $n = 10$ ), which was among the least occupied of the management types; this exception may be explained by the fact that vegetation was relatively sparse at these sites and the sedge plugs (although mostly eroded away) provided one of the few food sources. Even if sedge is a particularly important feature defining habitat suitability for water voles, it seems likely that, in its relative absence, water voles are able to (at least partially) compensate by feeding on a range of other plant groups. The highest diversity of plant groups identified from feeding remains (9) was recorded at bare bank and sedge plug ledge (8) sites (Figure 5), where the abundance of sedge was relatively low compared with coir roll revetment and natural sedge sites (as shown in Figure 6).

As previously alluded to, the same general trend can be seen in Figures 5 as in Figure 6, in that more sedge and reed sweet grass feeding remains were found where these species were more plentiful. In particular, sedge was especially abundant at coir roll revetment and natural sedge sites (DAFORN scores 3.43 and 3.41 respectively). Reed sweet grass was most abundant at bare bank and hard engineering sites (DAFORN scores 2.06 and 1.57 respectively).

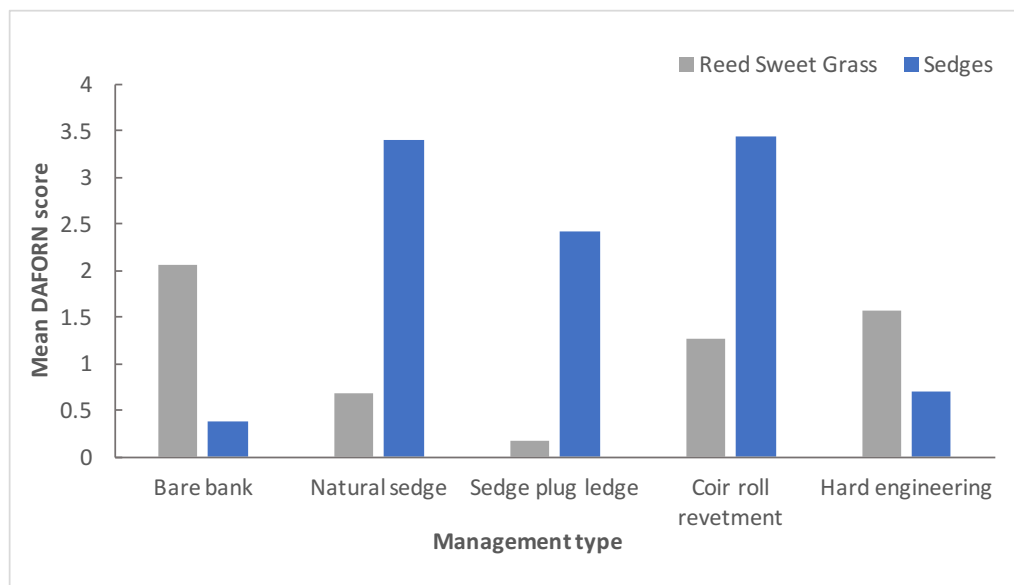
**Figure 6.** Mean DAFORN abundance scores (5 = Dominant; 4 = Abundant; 3 = Frequent; 2 = Occasional; 1 = Rare; 0 = None) for the two most dominant food plants (reed sweet grass and sedge) across the five management types.

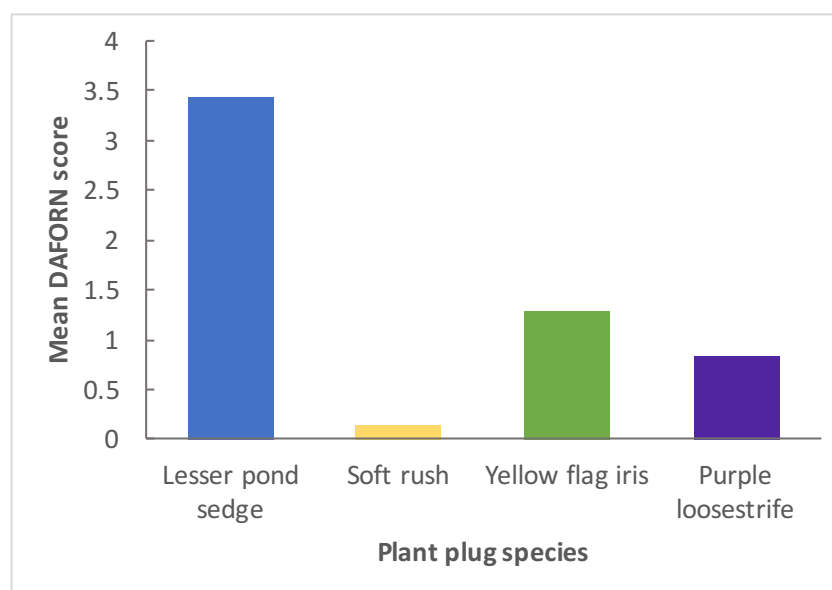
**Figure 7.** Mean DAFORN abundance scores (5 = Dominant; 4 = Abundant; 3 = Frequent; 2 = Occasional; 1 = Rare; 0 = None) for four of the five pre-established coir roll revetment plant plug species.

Of the five pre-established plant plug species incorporated in the coir rolls, reed canary grass was not recorded during survey visits since it could not reliably be identified from other grass species. Considering the other four species, lesser pond sedge was by far the most abundant, with a DAFORN abundance score of 3.43 (Figure 7), indicating that it has persisted and established well. The second most abundant plant plug species was yellow flag iris, with an abundance score of 1.28, less than half that of the sedge. Purple loosestrife and soft rush were the least abundant plant plug species within the coir rolls, with abundance scores of 0.83 and 0.14 respectively; these low abundance scores indicate that these species did not establish as successfully, possibly due to species competition.

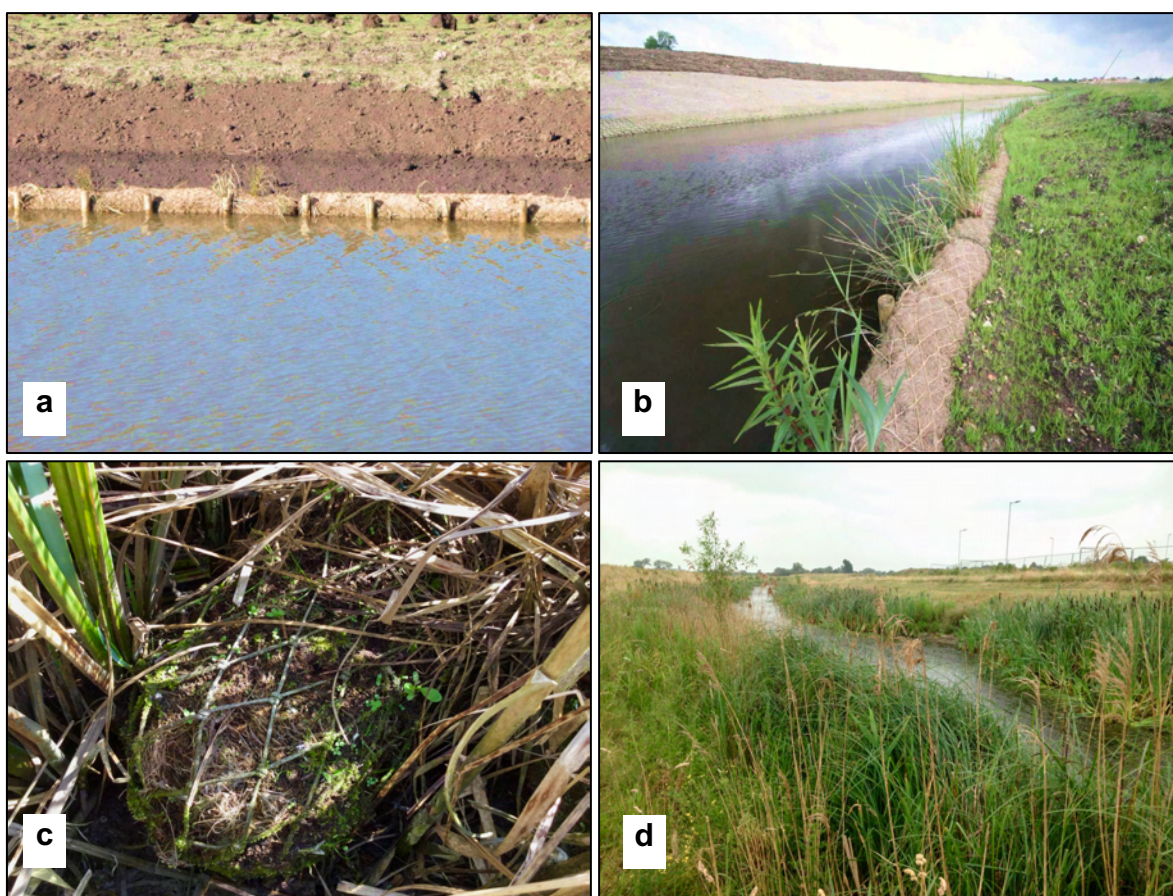
**Figure 9.** Fillenham's Drain coir roll revetments: (a) The bank just after installation (March 2014); (b) The bank two months after the installation showing pre-established plants beginning to thrive (C. Carson, May 2014); (c) The end of a section of coir roll located near raft 2 (L. Stoddart, 19<sup>th</sup> April 2017) (d) Site location of raft 2 (L. Stoddart, 6<sup>th</sup> July 2017).

The 210 metres of coir roll revetments (installed in 2014) along the banks of the diverted section of Fillenham's Drain appear to be well established in terms of vegetation growth (compare Figure 9d from 2017 with Figures 9a and 9b from 2014). The growth of the pre-established plants within the coir rolls and the natural vegetation extending in front of the rolls themselves (Figure 9c) have created a densely vegetated and species-rich margin that has become self-sustaining. Of the five pre-planted coir roll species, lesser pond sedge appears to have colonised the rolls and surrounding bank particularly well (Figure 9d). Lesser pond sedge was present at all five survey sites and earned the highest mean DAFORN abundance score of 4.55 (Table 4). The next most abundant of the pre-planted species was soft rush, which was present at three of the five sites, but earned a DAFORN abundance score of just 0.60. The presence of yellow flag iris was not recorded at any of the five survey sites (possibly crowded out by other, more dominant plants), thus resulting in a DAFORN score of 0.00. The difference between these scores highlights just how successful pre-planted sedge plants have been at colonising the banks, compared with other species. Short grasses were the most abundant non-pre-planted species, earning a DAFORN abundance score 3.15.

The vegetated coir rolls appear to have prevented any potential erosion from the channel current, and fluctuations in water level. The wooden posts securing the coir rolls at the water's edge are still in place and the coir roll structure (netting and coconut husk material) is still intact, as shown in Figure 9c.

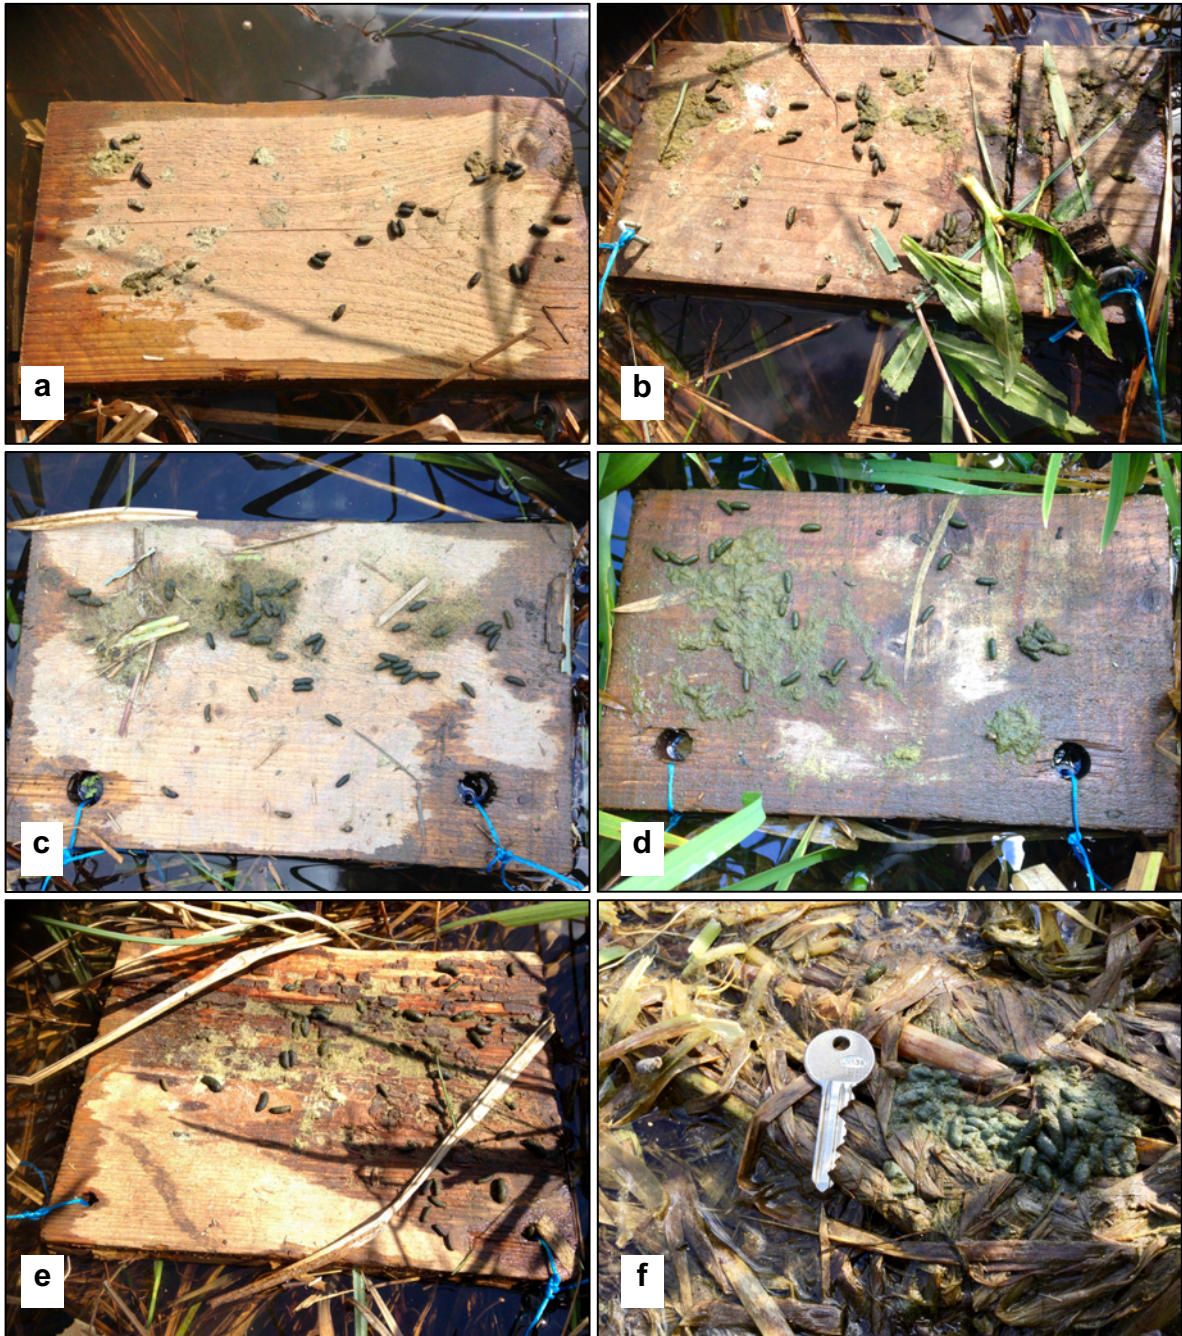
**Figure 10.** The five survey rafts acting as artificial latrine sites along the diverted section of Fillenham's Drain: (a) Raft 1; (b) Raft 2; (c) Raft 3; (d) Raft 4; (e) Raft 5 (L. Stoddart, 18<sup>th</sup> May 2017); and (f) A natural bank latrine site, with key for scale (L. Stoddart, 19<sup>th</sup> April 2017).

At each of the 110 survey sites (Figure 2), a wooden raft measuring 40x20 cm was installed by tethering it to the bank using string and bamboo canes. These rafts acted as artificial latrine and feeding sites allowing the presence of water voles to be easily recorded (following Richards et al., 2014).

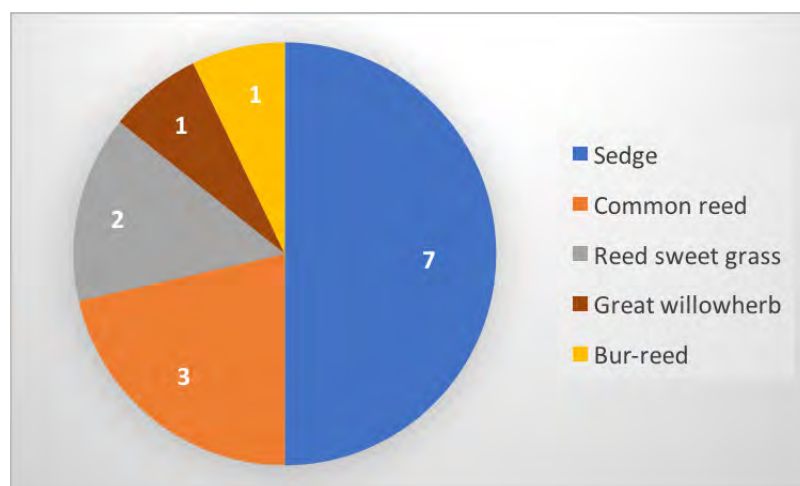
**Figure 11.** Number of the 20 Fillenham's Drain coir roll revetment survey visits (4 visits at each of the 5 sites) during which plant groups were identified from feeding remains.

As recorded for coir roll revetment sites more generally (Figure 5), sedge was the most frequently recorded plant from feeding remains at Fillenham's Drain sites (Figure 11). Sedge feeding remains were recorded during seven of the Fillenham's Drain survey site visits, making up 50% of all visits during which feeding remains were found. This finding indicates that sedge was perhaps proportionally even more important a primary food source at Fillenham's Drain sites than at coir roll revetment sites more generally. Aside from sedge, none of the other four pre-established coir roll plant species (yellow flag iris, soft rush, purple loosestrife and reed canary grass) were recorded from feeding remains, thus emphasising the importance of sedge. Common reed was the second most popular food plant at the Fillenham's Drain sites ( $n = 3$ ), constituting 22% of feeding remains. Despite the relative popularity of common reed and reed sweet-grass as food plants, it is inadvisable to incorporate these plants in coir rolls for the benefit of water voles since they are deemed invasive for reasons previously mentioned for reed sweet-grass (Carson, 2011; Weiss & Dugdale, 2017). In addition to the feeding remains recorded during the survey visits, Bulrush (*Typha latifolia*) feeding remains were also recorded (on one occasion) outside of the survey period.
