**Water voles in the Middle Level:
a three-year study of water vole populations at
Curf Fen and Ransonmoor, Cambridgeshire.**

A Report for the Middle Level Commissioners

February 2006

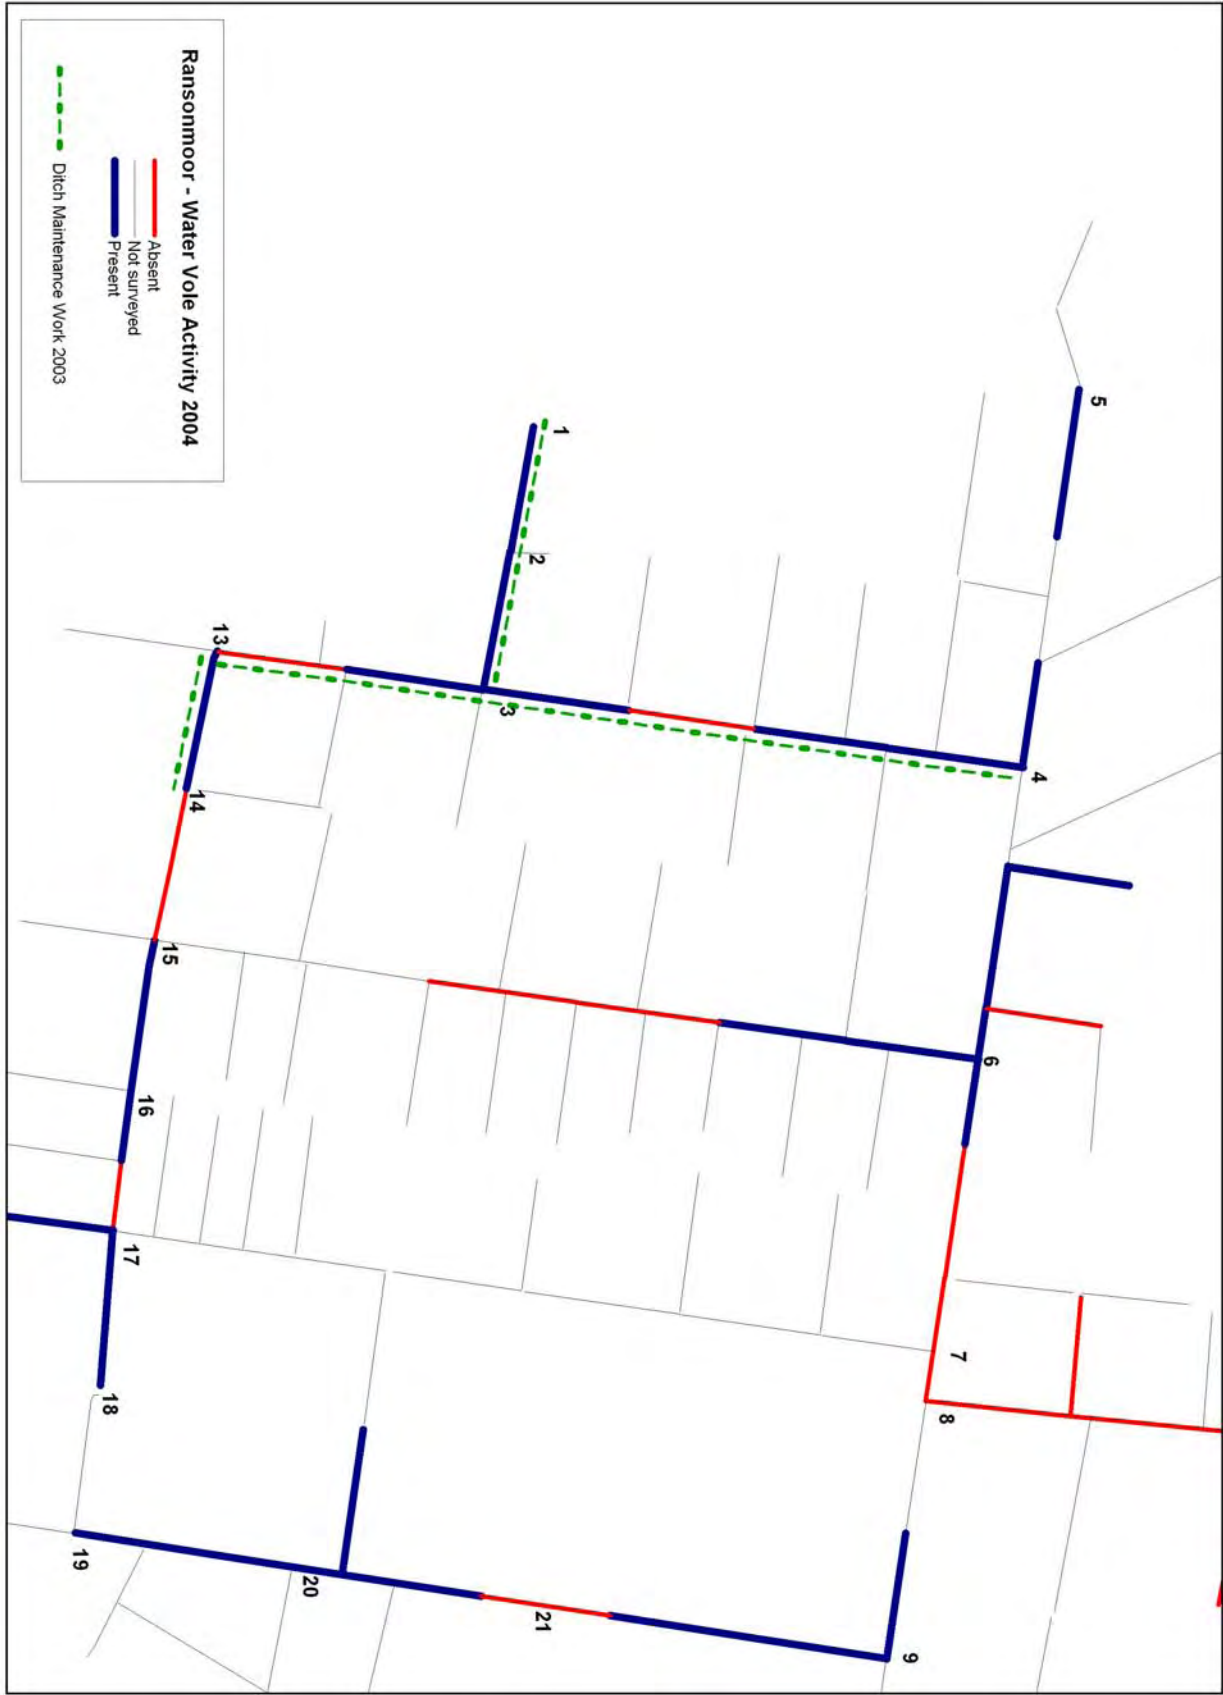
Figure 4.3F, Ransommoor - water vole distribution summer 2004, following winter ditch work (Section 4-13 side trimming, sections 1-3 & 13-14 de-silting only).
