MIDDLE LEVEL COMMISSIONERS

Engineer's Report

Report on Engineering Period
April 2015 to March 2016

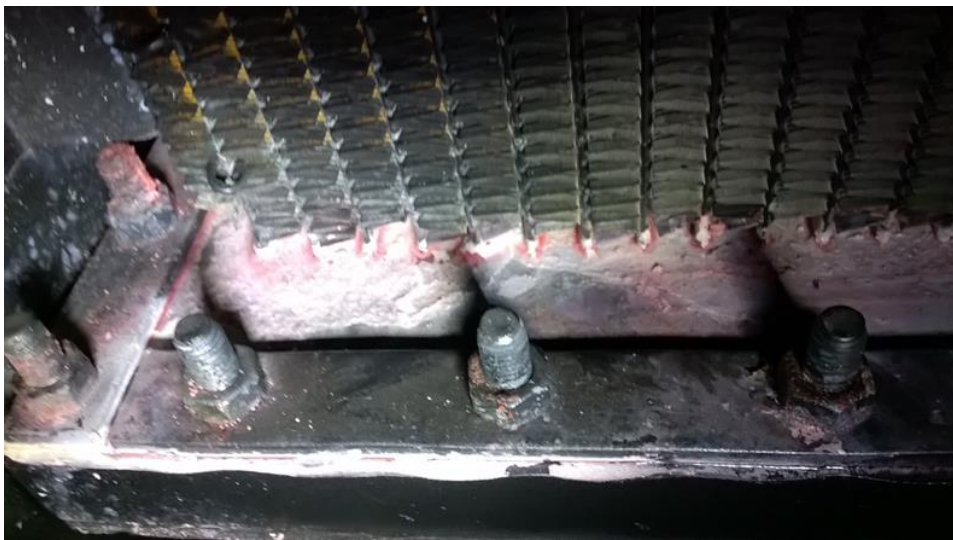
In parallel with the tests carried out by the University a suitable balancing agent was sourced and on the 21st August 2015 the No 3 diesel engine coolant was dosed with a chemical to lower the pH. Unfortunately during this exercise a small but significant leak was noticed and investigated (See photo).

The leak on No 3 engine is, as far as can be seen, on the aftercooler heat exchanger as was the case with No 6 engine (aftercooler exchanger replaced May 2013). The results of the dosing are very promising bringing the pH down from 11.3 to 9.76 and at the time of writing this report the coolant pH remains at this lower level. The leak on No 3 engine is manageable and so will be monitored closely but visual inspection strongly suggests a set of new cores will be required within 6-12 months.

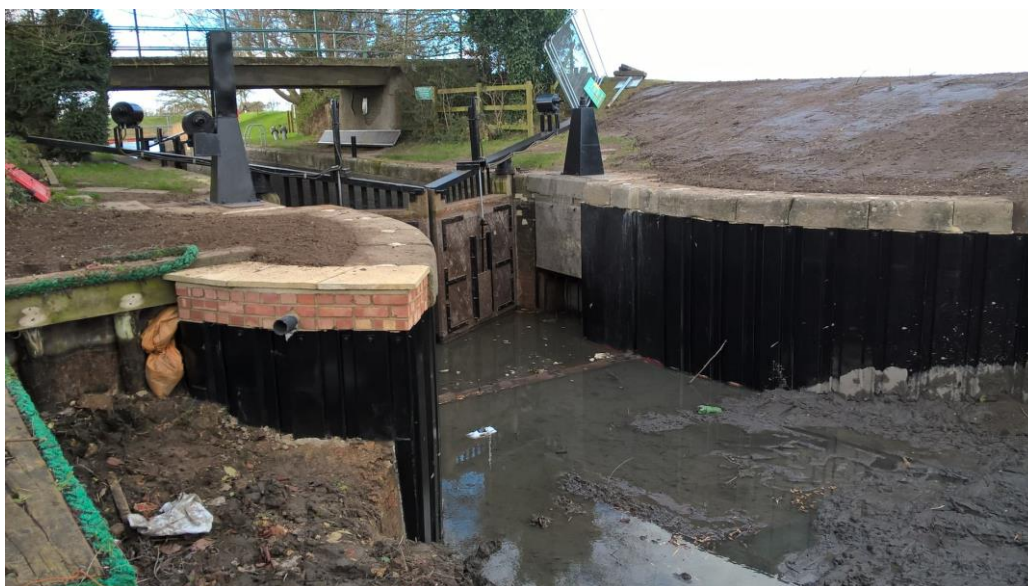
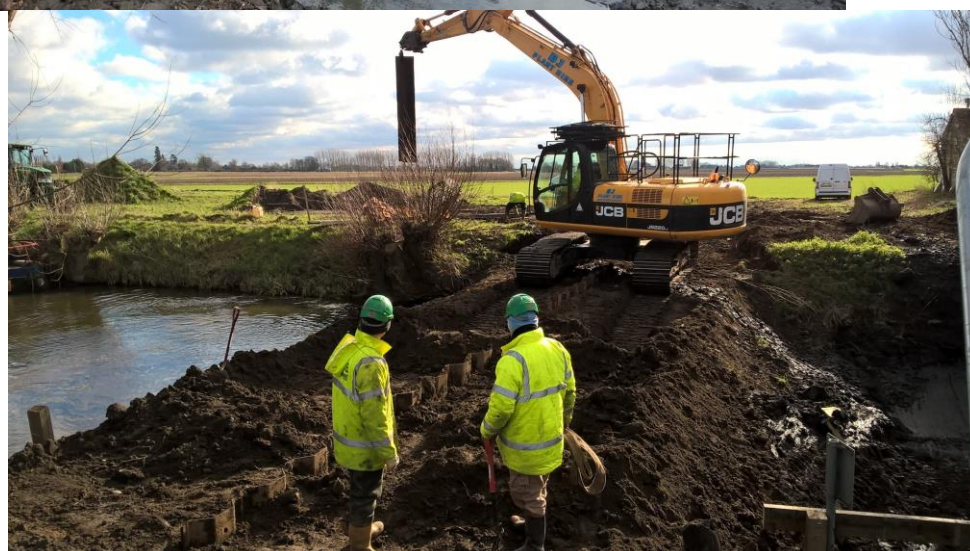
Refurbishment works on Marmont Priory Lock

Marmont Priory Lock – planned remedial work in the entrance to the Lock was successfully carried out over the winter period. Due to excessive spalling of brickwork on the eastern entrance to the Lock it was necessary to reface the wall with sheet piles and fill the resulting void with cement.

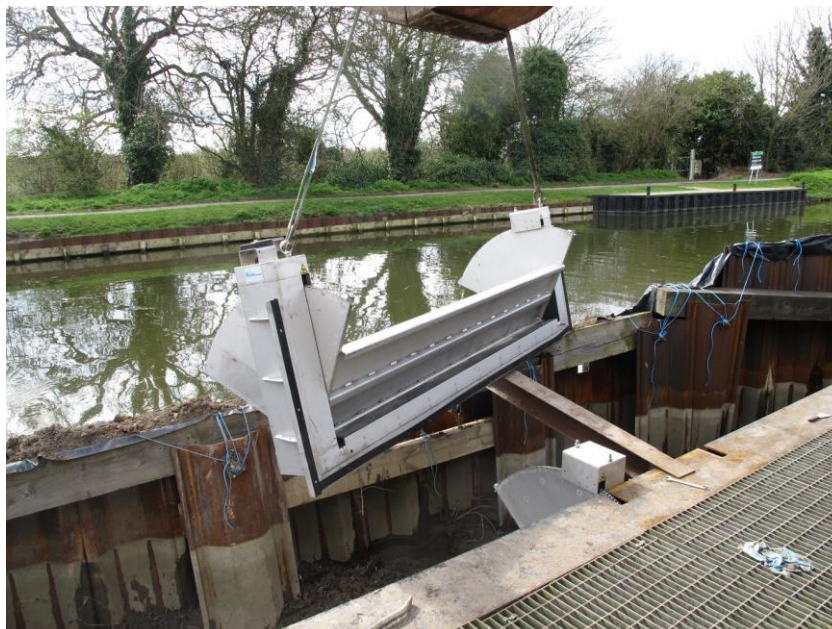
Ashline Lock Bypass Weir – the operating mechanism of the southern weir failed and following investigation it was found that the gate itself had seized in its guides. It was

subsequently dammed off for inspection and refurbishment or replacement. Having inspected the structure and fully considered the options, taking into account the number of times that there have been issues with the gate operation and that its design is considered poor, it was recommended to the Executive Committee that the replacement option be pursued. Following approval from the Executive Committee to proceed, quotations were obtained from three suppliers of Beamless Tilting Gates and Drop Down Weirs and subsequently an order was placed with HC Water Control for two Stainless Steel Beamless Tilting Gates, delivery and installation is planned for early April 2016.

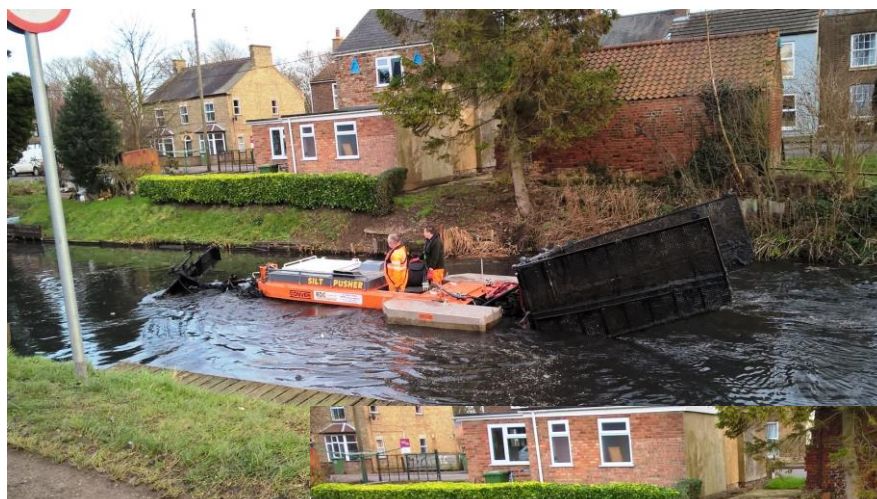
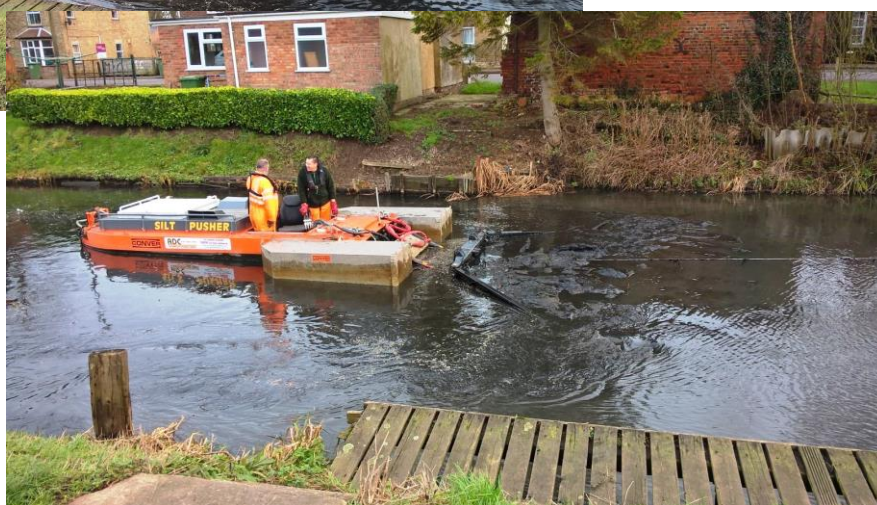
An offer by a local drainage contractor (ADC East Anglia Ltd) for a free day’s trial and evaluation of its newly acquired silt pushing boat was accepted. The trial was timed to coincide with the availability of the Commissioners’ Contractor’s hydraulic long reach machine being available on site to remove the pushed silt material from the watercourse

onto an arable field at the upstream extent of the trial area. The working trial highlighted that the silt pushing technique can prove of value where the working area or bankside access for a conventional hydraulic machine is limited or not available.

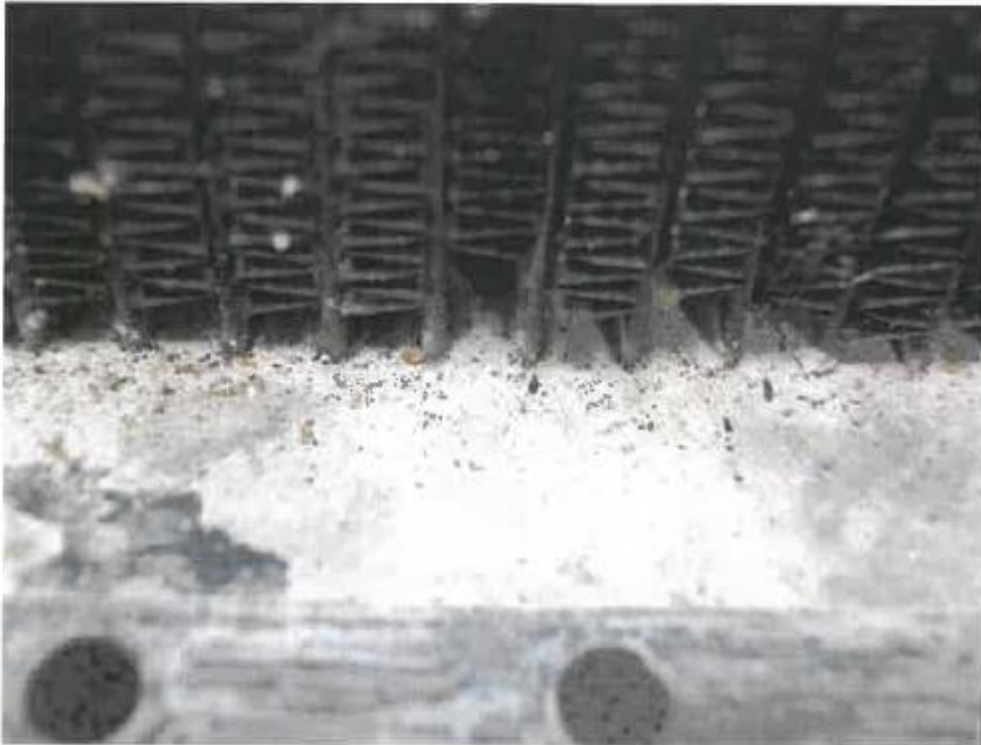
Figure 1. Bottom endplate, showing vertical tubes, "zig-zag tape" between tubes and pale brown/cream deposit on endplate. This is the surface normally exposed to air, not the "coolant" side of the heat exchanger.

The heat exchanger appears to have leaked from multiple positions where the tubes are joined into the end plates, at both the top and bottom of the heat exchanger. This is indicated by the runs and pools of pale-brown corrosion product/deposit at these positions, and showing the paths taken by liquid escaping from these positions, figure 1.

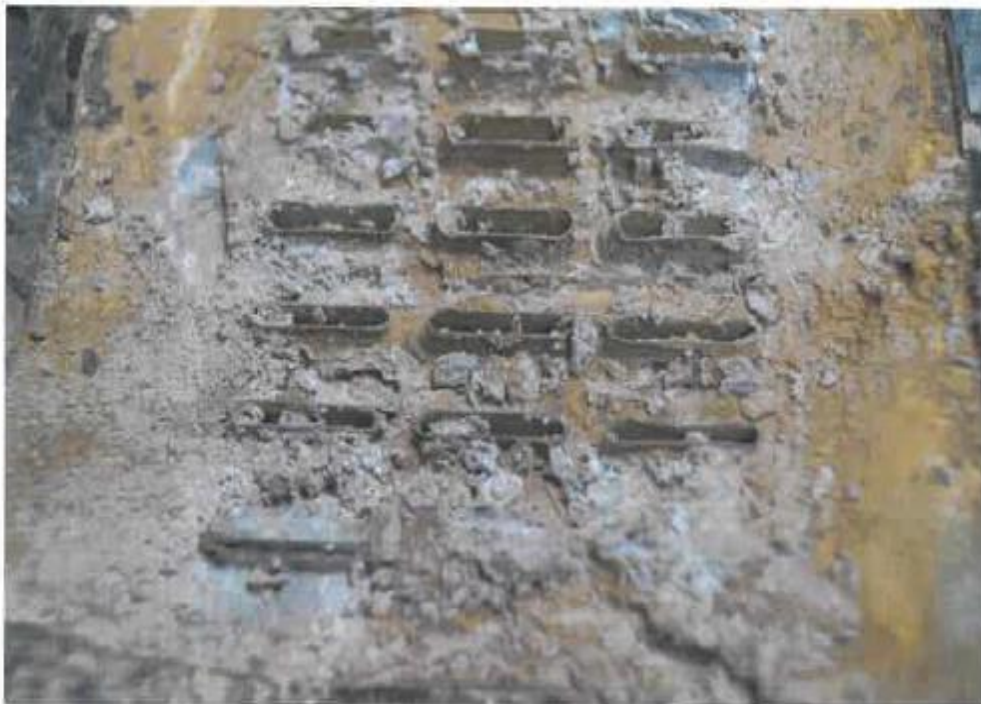
Figure 2. View of heat exchanger endplate "coolant side", showing copious deposits of corrosion product.

The endplates, viewed from the side normally submerged in coolant (figure 2), are covered in copious deposits of largely pale brown corrosion product. When the corrosion product is gently scraped away, little or no solder can be seen at the join between the tubes and the plate. The corrosion product is fragile and easy to remove.

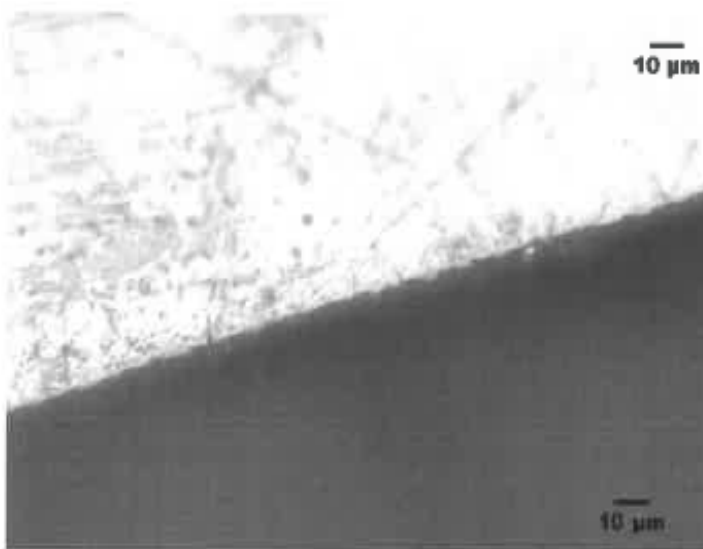
Figure 3.

Outer surface of brass heat exchanger tube, on the "coolant side" of the plate.

The optical appearance of the tubes and plates confirmed that they were made of brass. In places where the coolant had not been in contact with the metal (on the "air" side of joints and under the sealing gasket), a thin coating of silver coloured metal was observed, (figures 3 and 4). EDX analysis (below) confirmed that this was tin.

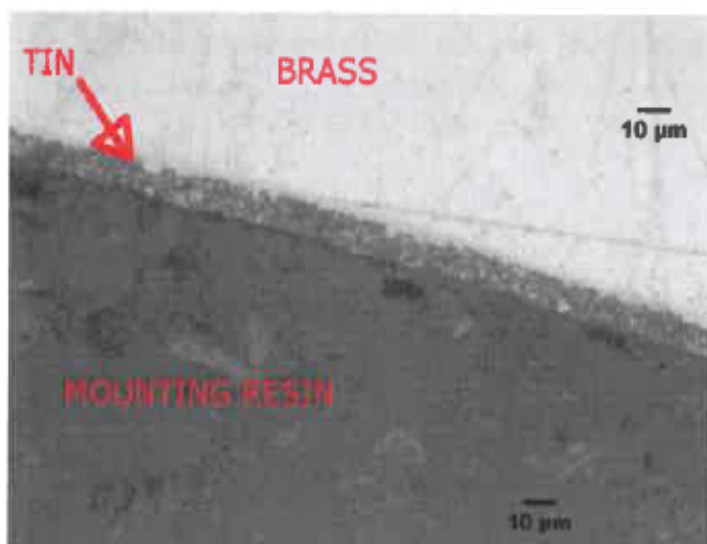
Figure 4.

Outer surface of the tube shown in figure 2, on the "air side" of plate. Note the tin coating, approximately 10µm thick. Note that the brass/tin interface is fundamentally flat, smooth and, very similar in appearance to the exposed brass surface in figure 3, suggesting little or no attack on the brass.

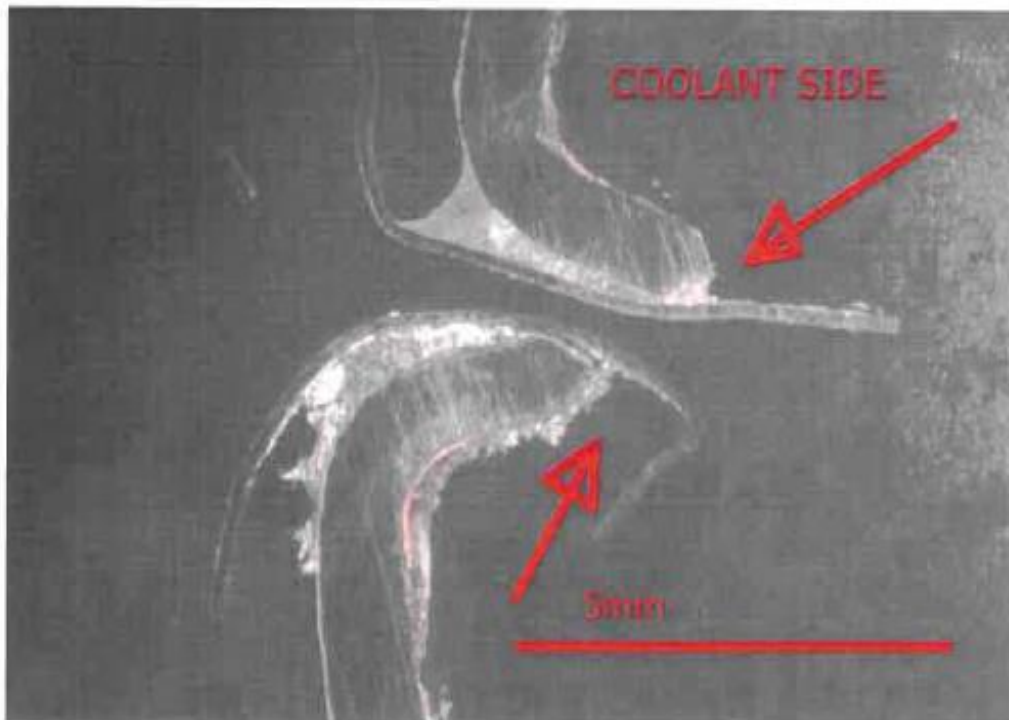
Figure 5. Optical image of a section through a tube/plate joint. Arrows indicate where solder is missing. The tube was flared open to admit the mounting resin, despite this, the pressure used has caused some distortion and narrowing of the central part of the tube sample.

At the joints, no solder was observed on the "coolant" side of the plate, only a little pale, apparently non-metallic deposit (figure 5). However, the distribution of the various substances is made considerably clearer in the electron microscopy and X-ray mapping imagery, in the next section.

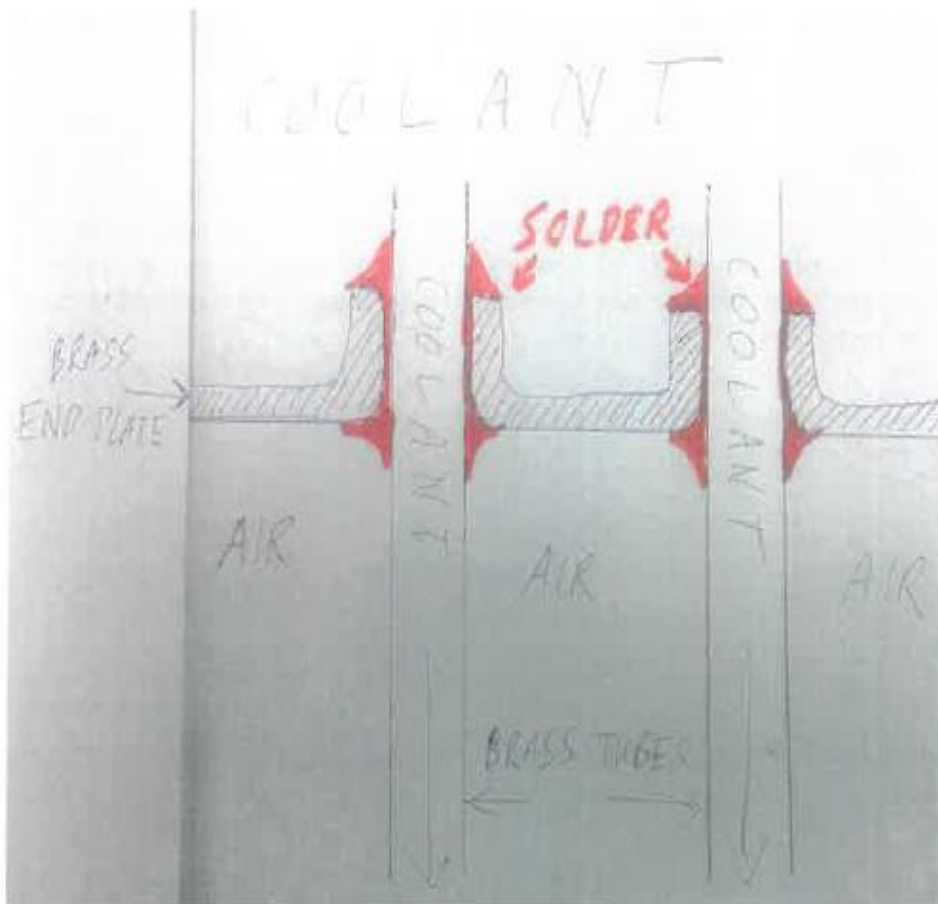
Figure 6. Sketch showing how the tube/plate joints would be configured, ideally.

In the positions where the plates had been pierced to accommodate the tubes, the plates had been bent "upwards" (or downwards, in the case of the bottom end plate), such that a lap joint was formed between the tube and the plate, rather than a simple hole through which the tube was passed. This lap joint would have been filled with solder in order to join the tubes to the plates and to make a seal. A sketch of an "ideal" joint is given as figure 6.

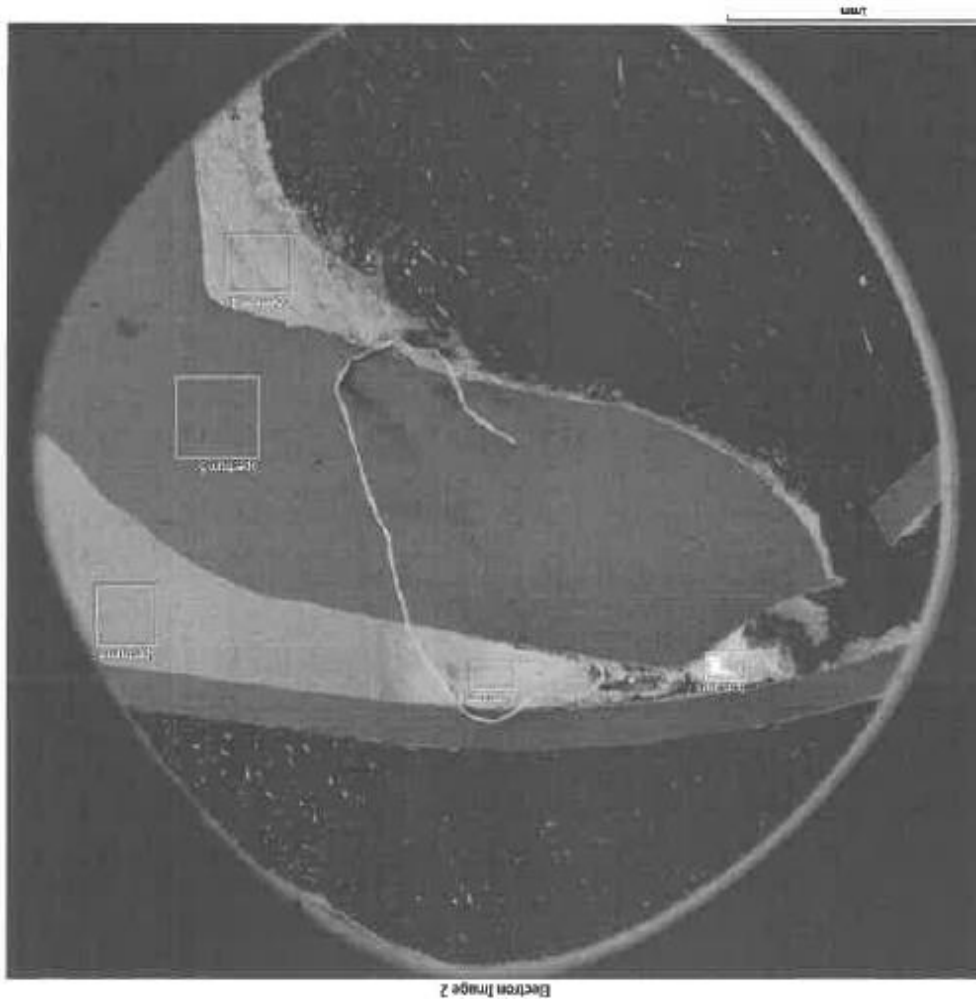
Figure 7. Electron microscope image of a section through a tube/plate soldered joint, showing areas from which EDX analyses have been taken (Spectrums 4, 5, 6, 7 & 8, shown below as figures 8-12).

Note that the image has been rotated by 180° in order to place the "coolant side" at the right hand side of the page, as it is in the other microscope images in this report.

Figure 8. Spectrum 4 from Figure 7 above. The elements detected are lead (Pb) and oxygen (O), with a trace of tin (Sn). Indicating that this is corrosion product largely composed of lead oxide/hydroxide/plumbate (hydrogen is likely to be present but is not detectable by EDX).

Figure 9. Spectrum 5 from Figure 7 above. The tube plate. The elements detected are copper (Cu) and zinc (Zn), in a ratio of approximately 70/30 indicating that this is 70/30 brass.

Figure 10. Spectrum 6 from figure 7, above. An area of solder, unaffected by the corrosion. The detected elements are lead (Pb), the majority constituent, tin (Sn), and a detectable trace of silver (Ag), which is frequently found in trace quantities in lead. Also present (unlabelled peaks at about 0.9 and 8 keV) is copper (Cu), which has presumably transferred from the brass during sample polishing. Copper is not found at other positions in the solder. The analysis computer estimates the lead:tin ratio as about 90% lead, 10% tin (by mass). Thus it seems that the solder used was a solder of 95-85% lead, 5-15% tin, most likely 90/10.

Figure 11. Spectrum 7 from figure 7, above. Corrosion product. The detected elements are lead (Pb), tin (Sn), oxygen (unmarked peak of height 1 at 0.5 keV) and silver (Ag). This analysis suggests that the corrosion product is enriched in tin and silver and depleted in lead, relative to the original solder. This is contradicted by spectrum 4 above, and by other results shown below, indicating that the composition of the corrosion product is not uniform.

Figure 12. Spectrum 8 from figure 7, above. Corrosion affected solder/early stage corrosion product. Elements detected are lead (Pb), oxygen (O), and tin (Sn). It is unclear from this analysis and spectrums 4, 6 & 7 above, whether the first stage of corrosion preferentially attacks the tin, the lead, or both equally. This question is resolved by element mapping results, shown below.

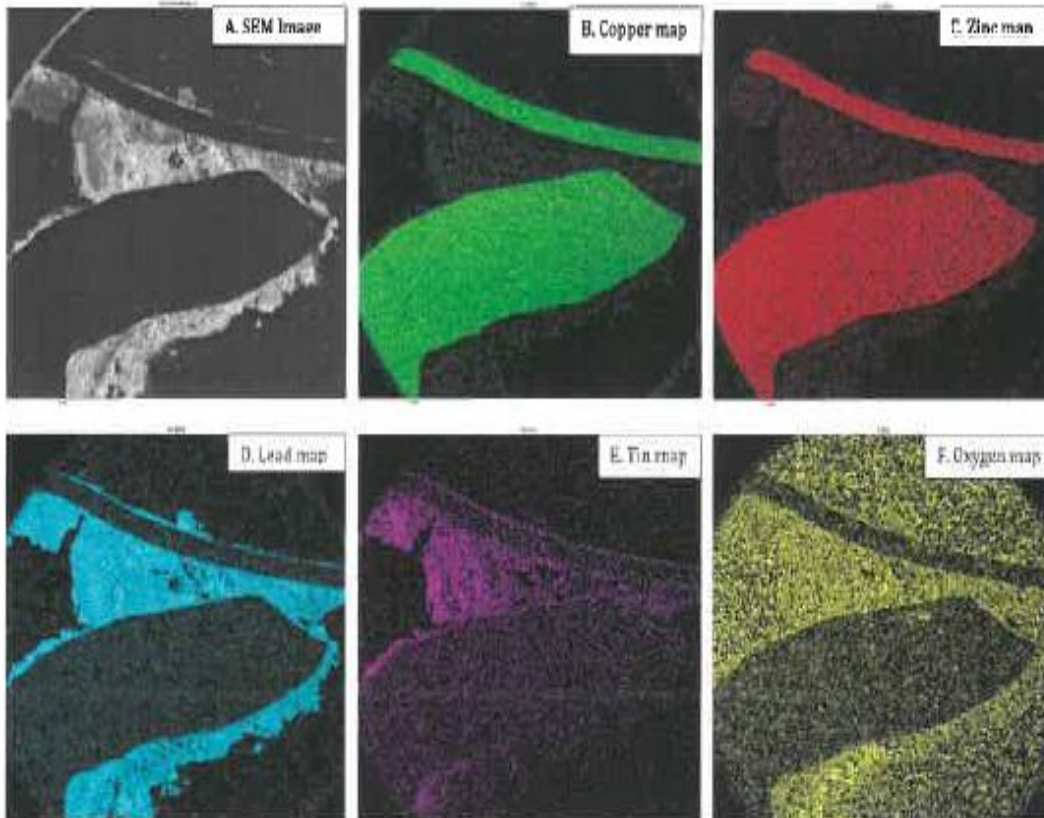
Figure 13. Electron microscope image and elemental maps of a section through a tube/plate joint. Note the gradient of tin concentration in fig. 13 E, and the near-absence of tin from the coolant side of the plate (right).

Figure 13 A-F below, like figure 7 above, shows a section through a tube/plate joint, including the remaining solder and the corrosion products that partly occupy the space where the solder once was.

Figure 13 B and 13 C show that copper and zinc are confined to sharply defined areas (the brass parts) and are not found in any quantity elsewhere (though there is a little background noise). This lack of any significant copper or zinc in the corrosion product further suggests that the brass has not been attacked.

Figure 13 D shows that the quantity of lead in the solder (towards the left and top, where higher levels of tin are found), and the quantity of lead found in the corrosion product (where lead is high but tin low, towards the right and bottom (coolant side)), are similar. This suggests that the majority of the lead is not dissolving, but rather is converting in place to a solid corrosion product, which is then removed in many places, because it is mechanically weak and fragile.

Figure 13 E, and figure 14 (below) show the quantity of tin in the corrosion product/partly corroded solder trapped within the lap joint, and show that this depletes from the undamaged solder (left) towards the coolant side (right). This corrosion product is mechanically protected/trapped by the brass of the plate and the tube alongside it, so mechanical removal is not possible. Thus the tin depletion must be because it is dissolving into the liquid coolant and being carried away. This also suggests that attacking and dissolving the tin is the first stage of the corrosive action.

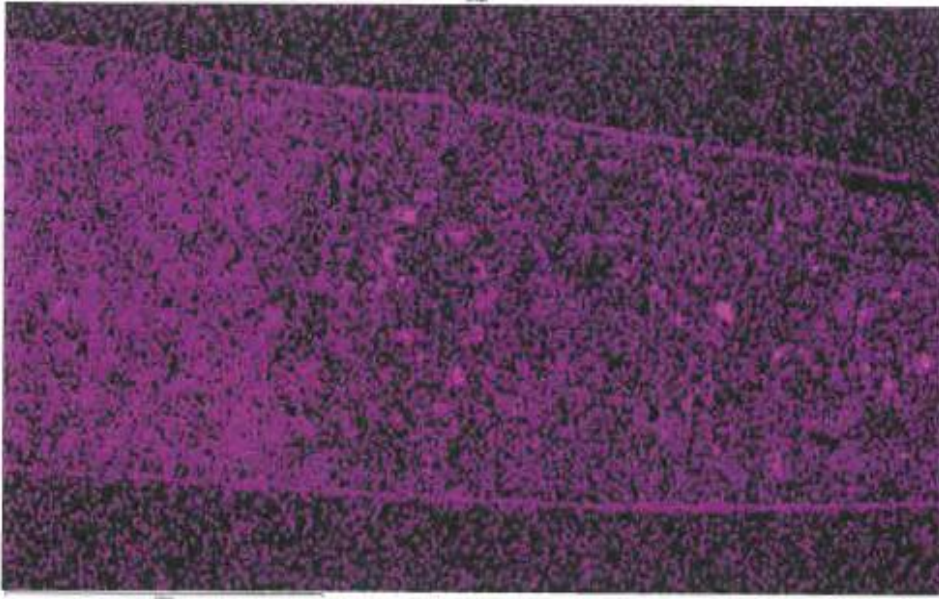
Figure 14. Tin map. Higher magnification detail of solder/early stage corrosion product (centre) trapped in the lap joint between the tube wall (below) and the plate (above). Bright lines along the surfaces of the tube and the plate are the tin coatings of the tube and the plate. Note how the quantity of tin in the solder depletes from the left (undamaged solder) to right (corroded solder, towards the coolant), with some suggestion of tin-rich particles/clumps forming.

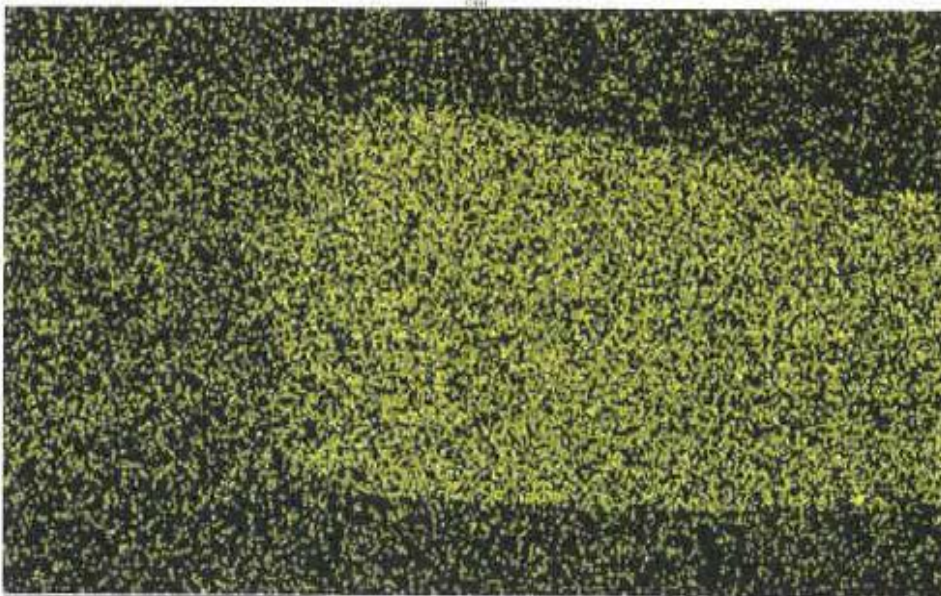
Figure 15. Oxygen map of the area shown in figure 14. Note how the quantity of oxygen increases as tin decreases, indicating a clear link between the tin depletion and the corrosion process.

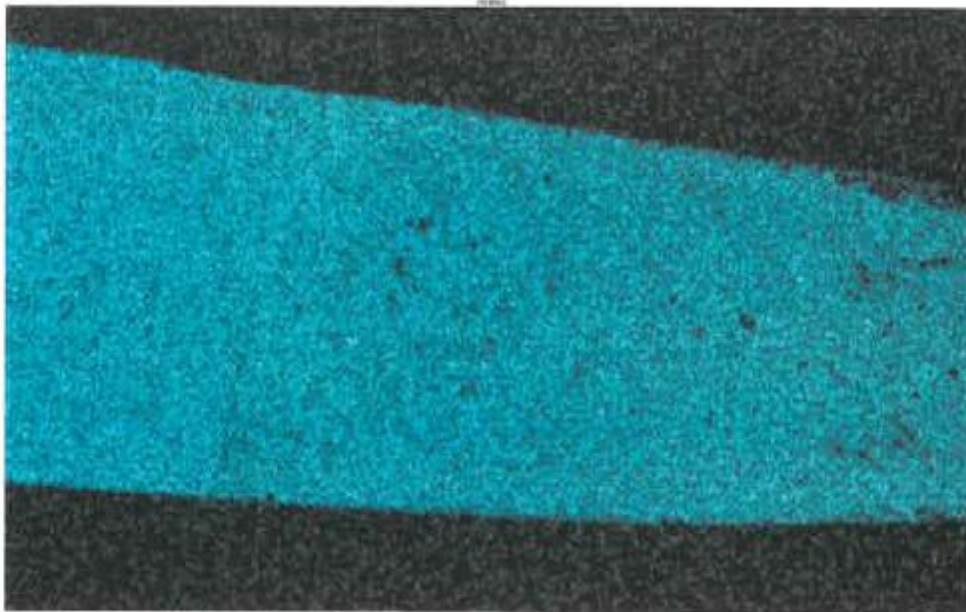
Figure 16. Lead map of the area shown in figures 14 and 15, above. Showing that the quantity of lead present is not greatly changed by the processes of dissolution of the tin or oxidation of the lead.
