Middle Level Commissioners Meeting 03/11/11

Environmental Officer's Report – April 2011 to October 2011

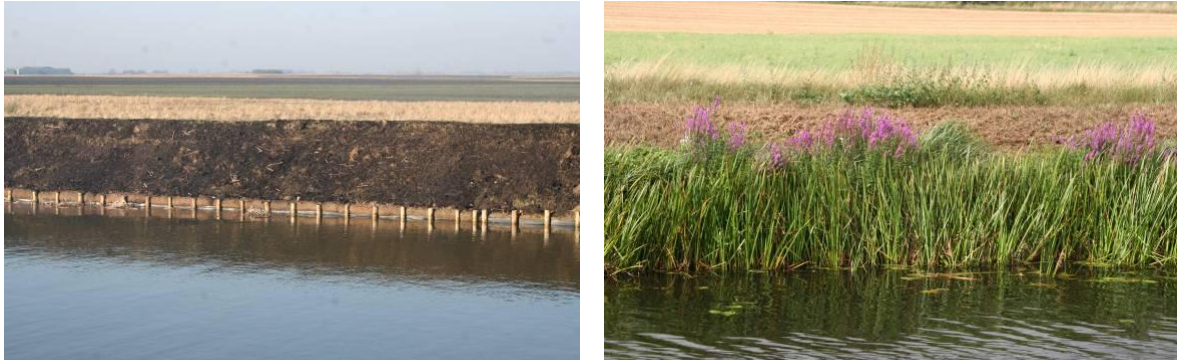
Coir rolls near Bedlam Bridge on the Sixteen Foot River, left, shortly after installation in 2009 and right, August 2011. Bur-reed has established naturally in front of the sedges, rushes and purple loosestrife that are growing out of the coir.

The 399 meters of pre-established coir roll revetment at nine sites created during the two previous years have continued to thrive. Vegetation at the three earliest installations has become established in front of the coir rolls, consolidating the installed material and providing a naturally regenerating margin at a previously eroded location.

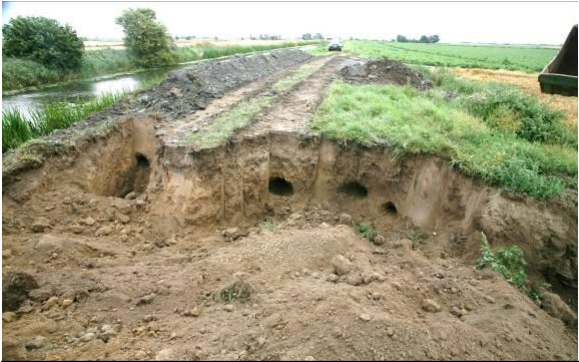
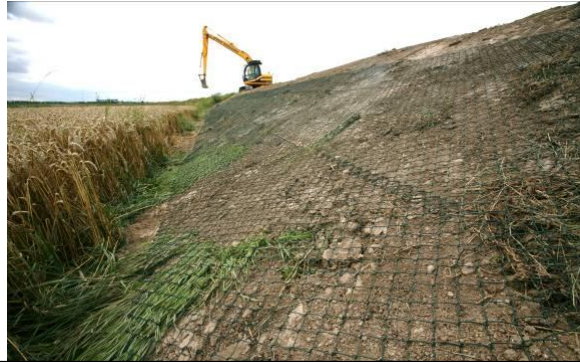
Left, the whole bank was rebuilt as badger holes had extended across it. Right, link mesh is pegged down prior to being covered with a thin layer of soil to prevent returns.

A licence to fit no-return doors at the location where badgers had established 16 holes at the back of the Black Ham near Bradford's Bridge was obtained and exercised. No attempts to burrow back into the site were attempted by badgers during the exclusion period. When the sett holes were opened up, extensive tunnelling throughout the bank was found as it had no clay core. A clay core was puddled in and link mesh fence wire installed to prevent re-excavation at the site.
